Condition assessment and retrofit of a historic steel-truss railway bridge

This paper presents an experimental and analytical study to assess the condition of a historic railway steel truss bridge still in use. The task is pursued through static and dynamic field measurements, as well as laboratory tests. A validated analytical model is employed to evaluate the capacity of the bridge to carry seismic and wind loads specified by current design codes, as well as the heavier trainloads set by the owner. Strengthening and replacement measures are proposed for bridge upgrade. An estimation of the remaining fatigue life of the bridge in its present condition and after the suggested strengthening is also made.

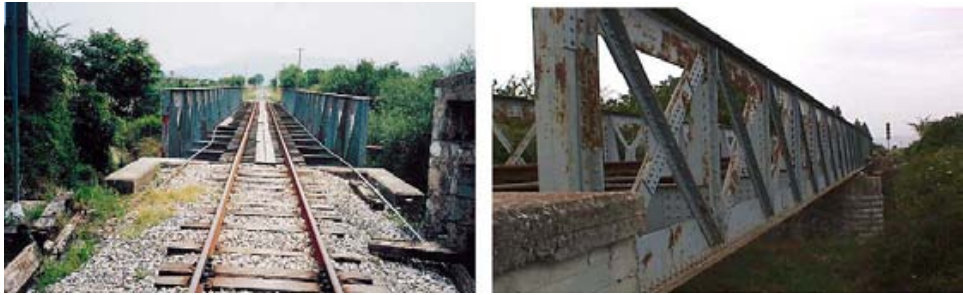
Fig. 1. General view of the steel bridge.

This work presents salient features of the procedure, as well as the results of a condition assessment and retrofit study for a characteristic steel-truss bridge of this railway network. The two-span bridge under consideration (see Fig. 1) consists of a symmetric structure about the mid-support steel superstructure of total length 42.40 m long. The main girders are two riveted trusses 2.00 m high and 4.00 m apart, while the main truss girder consists of combined plates and L sections, as shown in Fig. 2. At the bottom chord, the main trusses are connected with transverse secondary beams (SB1), a horizontal bracing system, and the longitudinal secondary beams (SB2), as shown in Fig. 3. In Fig. 4, dashed lines have been used to indicate the new steel plates added to the members that, according to the analysis elaborated in the following sections, need to be strengthened. A representative connection of the horizontal bracing system at the lower chord is shown in Fig. 5. The 20-panel bridge superstructure is supported through two restraining bearings at the intermediate massive unreinforced masonry piers and two simple sliding bearings at each end masonry pier (Fig. 6).

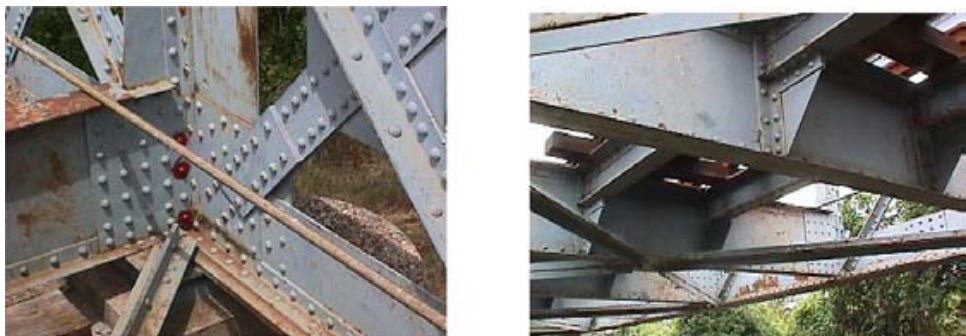
Fig. 5. Connection of the bracing system at the lower chord.

validates the rigid joint modeling is shown in Fig. 5. As a consequence, moments are transferred through joints and are proven to be of interest only for the top and bottom beams of the trusses, as well as for the floor and deck beams. Moments that develop in the vertical studs and diagonal ties are negligible.

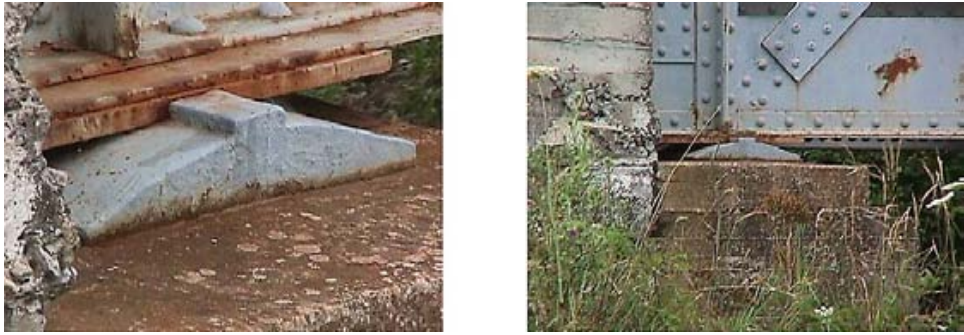
Fig. 6. Sliding bearing at end masonry piers.

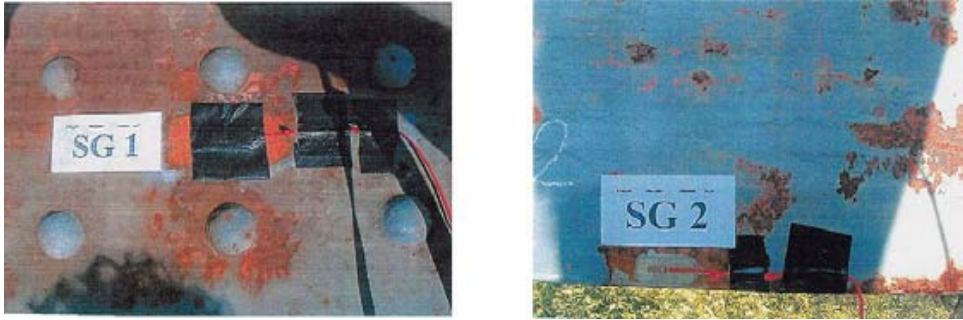
Fig. 8. Strain gauges placed at locations S_1 and S_2 .

engine track and carried out by a team headed by Prof. P. Karydis (Director of the Laboratory for Earthquake Engineering at NTUA). Specifically, the bridge was instrumented with strain gauges placed at selected locations to measure normal stresses, as shown in Figs. 7 and 8. In addition, the vertical vibrations were recorded with accelerometers having a sensitivity of 10 Volts/g (Fig. 9), placed at

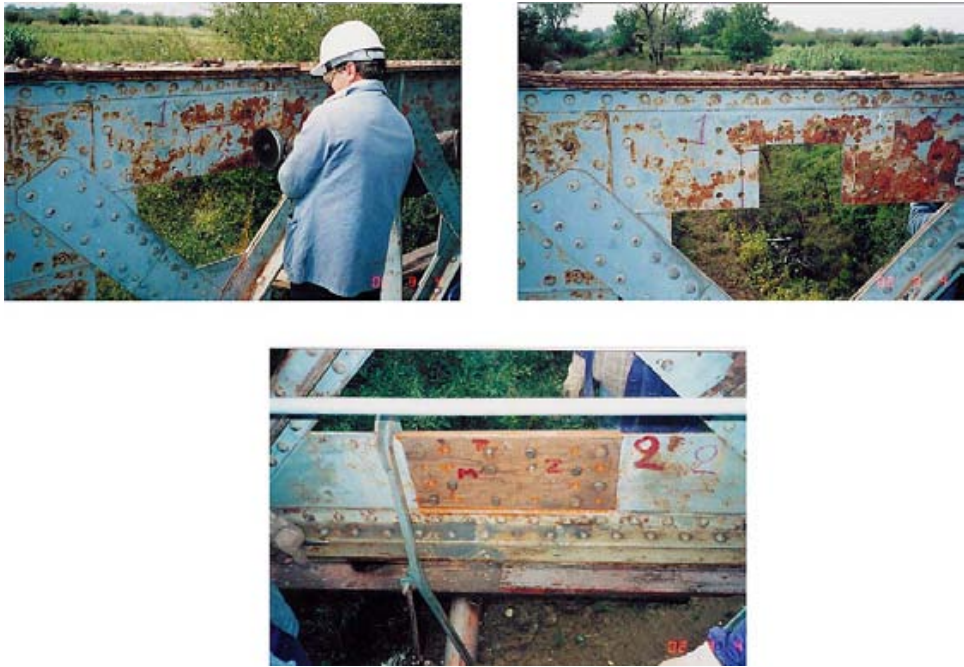
Fig. 10. Details from the locations of the extracted pieces.

Laboratory tests, such as tension tests, chemical analysis and fatigue tests, were also carried out on specimens extracted from representative members that are prone to fatigue [12]. More specifically, a sufficient number of specimens were extracted from the webs of the upper and lower chord of the main girder and from the web of the transverse beams, and the members were fully restored with riveted plates as shown in Fig. 10.

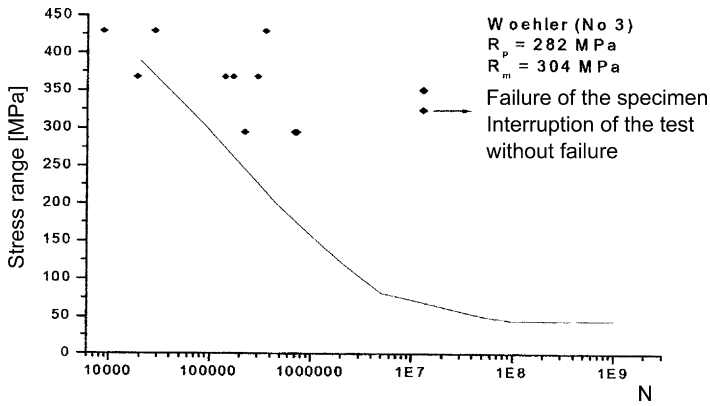
Fig. 11. Results from fatigue tests for the main girder.

Several specimens were used to perform fatigue tests. Figs. 11 and 12 depict the results of the fatigue tests together with the Woehler curve corresponding to detail category 112 of Eurocode EC3 [3]. In both figures, the fatigue strength of the tested material could be classified at least according to this detail category.

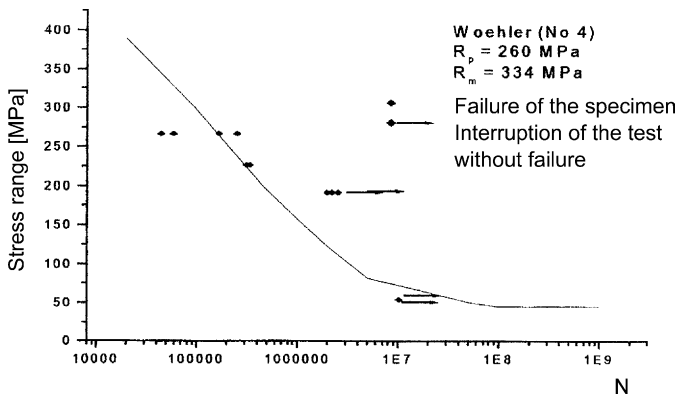
Fig. 12. Results from fatigue tests for the transverse girder.

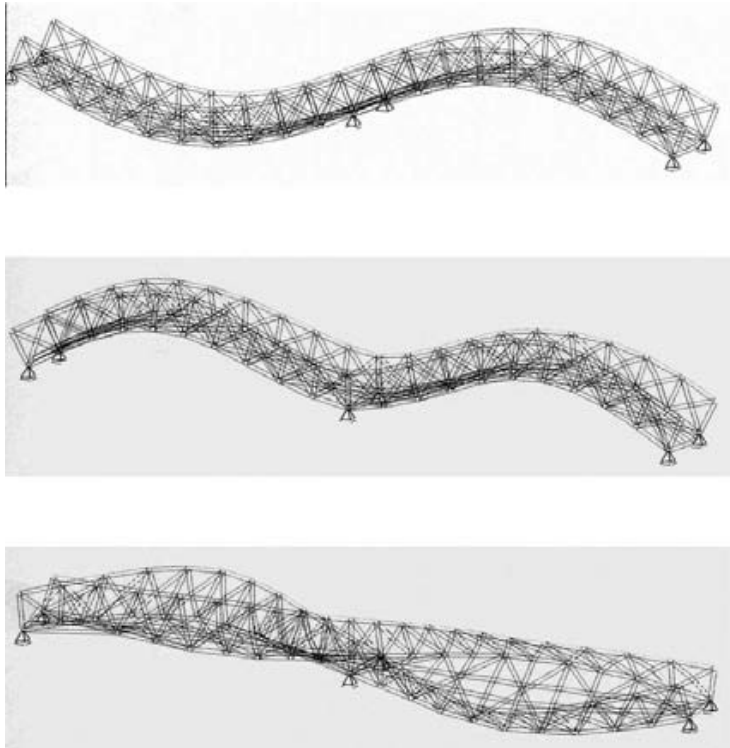
Fig. 13. First, second, and third vertical mode shapes.

The first three eigenperiods of the 3D finite element model of the truss bridge are listed in Table 2 and the corresponding mode shapes are shown in Fig. 13. The correlation between the measured and the calculated eigenperiods and modal shapes indicates the validity of the finite element model.

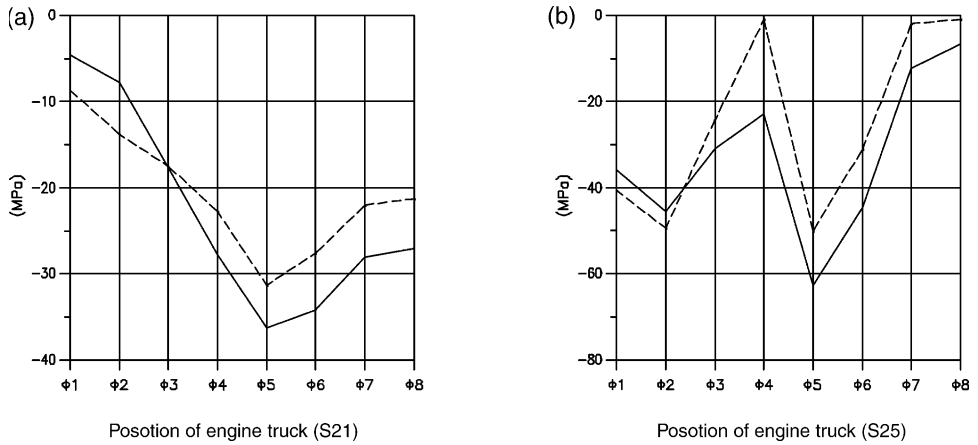
Fig. 15. Locations S21 and S25: Stress versus loading (Φ) (continuous line: tests, dashed line: analytical).

The stresses calculated from the analysis and those obtained from measurements at indicative locations are shown in Figs. 14 and 15. No significant differences are observed. However, conservatism in the calculations with the finite element model is preserved, since in most cases the analytical results are greater than the corresponding measured values.
