Validated analysis and strengthening of a 19th century railway bridge

John Ermopoulos^a, Constantine C. Spyrakos^{b,*}

Abstract

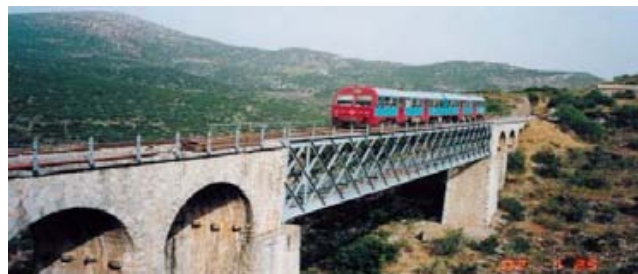
Fig. 1. General view of the steel bridge.

As shown in Fig. 1, the seven span bridge is symmetric with the six spans made of masonry, while the central span is a 51.60 m long steel superstructure. The main girders are two riveted parallel trusses 5.20 m high and 3.40 m apart; see Fig. 2. As shown in Fig. 2, the main truss girder consists of

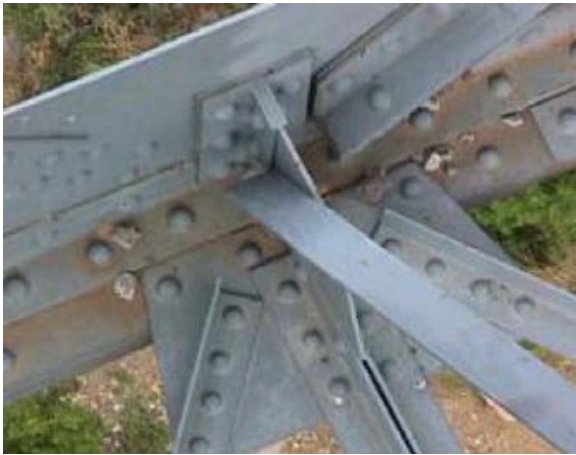
according to the analysis elaborated in the following sections, need to be strengthened. A representative connection of the bracing system at the lower chord is shown in Fig. 7. The 20-panel bridge superstructure is simply supported through two restraining and two roller bearings on massive unreinforced masonry piers.

Fig. 7. Connection of the bracing system at the lower chord.

connections according to the design specifications in [8]. A typical connection of vertical studs, diagonal ties and top beam of the truss system that justifies the rigid joint modeling is shown in Fig. 7. As a consequence, moments are transferred through joints and are proven to be of interest only for the top and bottom beams of the trusses as well as for the floor and deck beams. In the main girders, the moments that develop in the vertical posts and the diagonals are negligible.

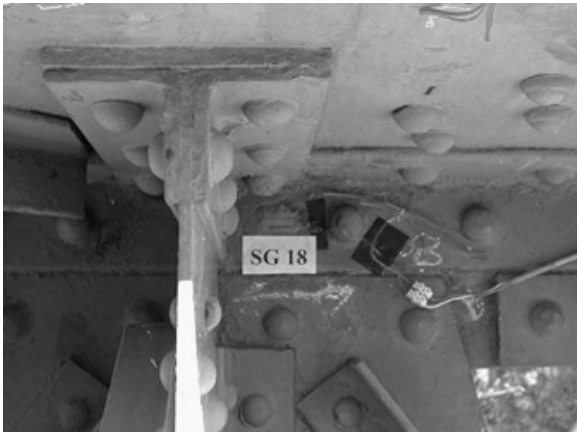
Fig. 9. Strain gage placed at location S_{18} .

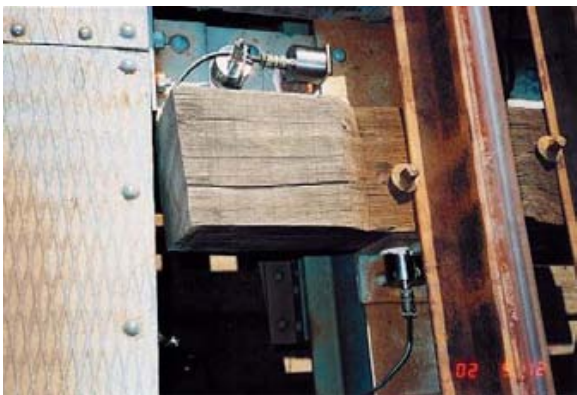
Fig. 10. Horizontal and vertical accelerometers.

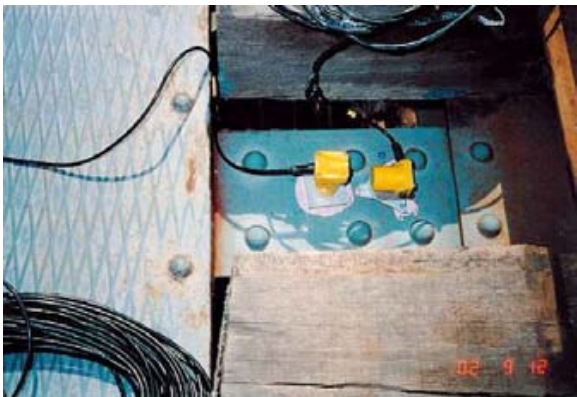
In situ measurements were performed using an 800 kN engine truck [11]. The in situ measurements were carried out by a team headed by Professor P. Karydis (Director of the Laboratory for Earthquake Engineering at N.T.U.A.). Specifically, the bridge was instrumented with strain gages placed at selected locations to measure normal stresses, as shown in Figs. 8 and 9. In Fig. 8 Φ_i ($i = 1$ to 8) indicates the position of the first axle of the six-axle engine truck. The distances between the axles are also shown in Fig. 8. During field-testing, the horizontal along the longitudinal and transverse axes as well as the vertical vibrations were recorded with accelerometers having a sensitivity of 10 V/g placed near the midspan of the bridge (Fig. 10). In order to measure the free-vibration, accelerations were recorded after the 800 kN engine had crossed the bridge. Strains were also recorded for trains that crossed the bridge in order to assess the behavior of the superstructure for currently used trains. These measurements were performed twice: once for each direction of the traveling train. The speed of the 800 kN engine truck as well as the regular trains were measured with geophones having a sensitivity of 28.8 V/m/s, (Fig. 11).

Fig. 11. Horizontal and vertical geophones.

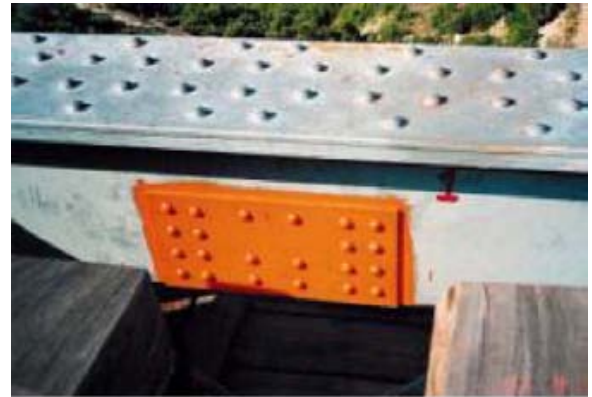
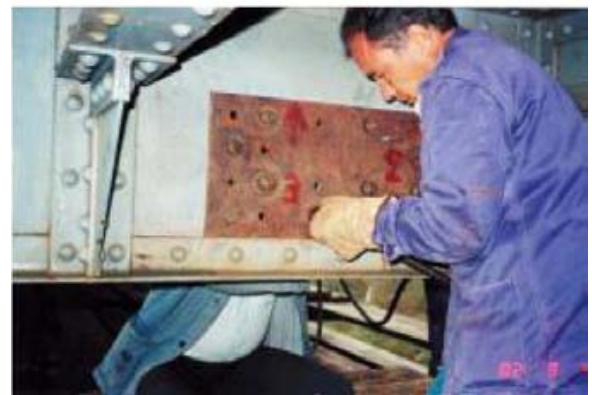
of the transverse beams, and the members were fully restored with riveted plates as shown in Fig. 12.

Fig. 12. Details from the locations of the extracted pieces.

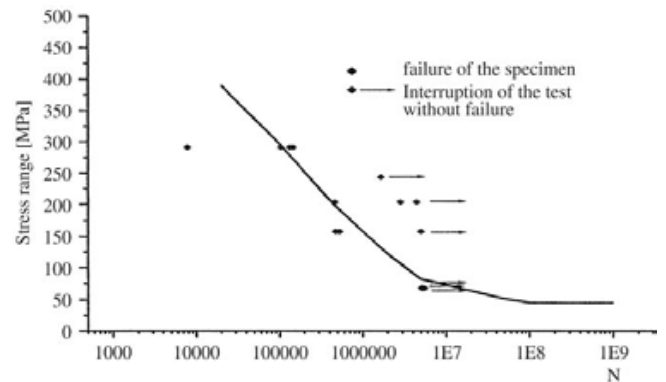
Specimens were also used to perform fatigue tests. The results of the tests are shown in Figs. 13 and 14. In these figures the curve corresponding to detail category 112 of Eurocode 3 was introduced [14]. In both figures the fatigue strength of

the tested material could be classified at least at this detail category.

Fig. 13. Results from fatigue tests for the main girder.

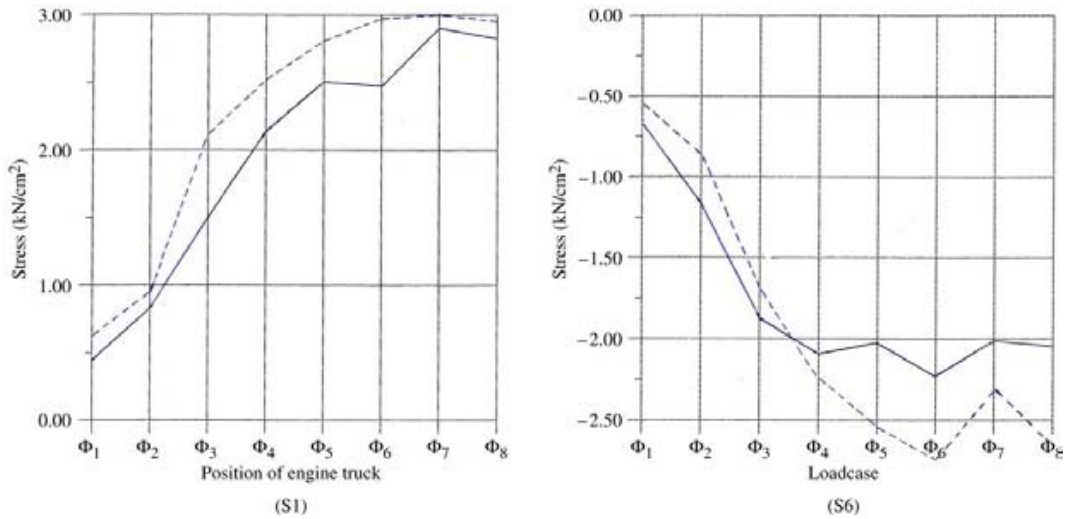
In Figs. 16 and 17 the stresses calculated from the analysis and those obtained through strain gages at indicative locations are shown. The differences are not significant. However, conservatism in the calculations with the finite element model is preserved, since in most cases the analytical results are greater than the corresponding measured values.

Fig. 16. Locations S1 and S6: Stress versus loading [Φ_i] (continuous line: tests; dashed line: analytical).

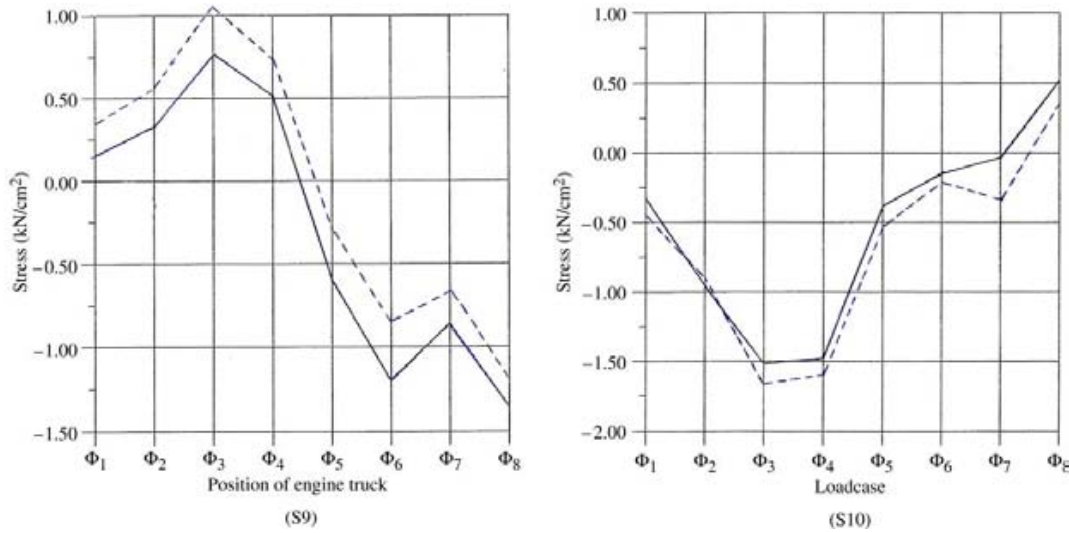
Fig. 17. Locations S9 and S10: Stress versus loading [Φ_i] (continuous line: tests; dashed line: analytical).
