ASSESSMENT OF SEISMIC RISK FOR MUSEUM ARTIFACTS

C.C. Spyrakos¹, Ch.A. Maniatakis² and I.M. Taflampas³

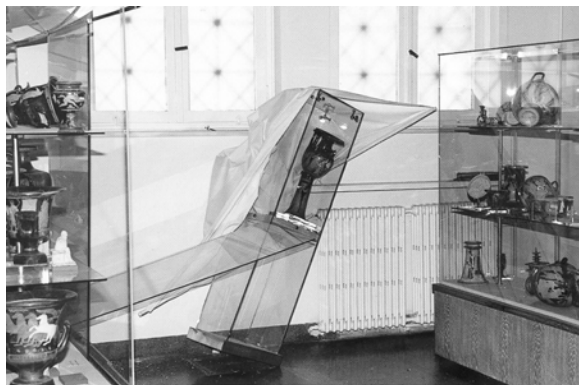
Figure 1 Failure examples of art objects and artifacts: (1.1) Failures caused by overturning at the National Museum of Athens during the 1999 Athens (Parnitha) earthquake (1.2) Failures caused by overturning and impact at the Archaeological Museum of Argostoli during the Kefalonia 2007 earthquake

Damages of both museum buildings and artifacts have been observed in many cases in Greece. The recent (1999) Athens earthquake not only caused severe damages to numerous engineered structures, but also to artifacts and statues in museums (figure 1.1). The 1999 Athens earthquake, with a magnitude defined as $M_L=5.4$ in the local magnitude scale and as $M_S=5.9$ in the surface wave magnitude scale, originated at a normal fault rupture with a focal depth of almost 12 km and at a distance of 18-20km from the historical centre of Athens. The event was unexpected since it occurred in a region traditionally considered as of low seismicity and there was no active fault mapped in the epicentral area. The earthquake mainly hit the northwestern Athens suburbs, which are close to the causative fault. More than 80 buildings collapsed, including industrial facilities, causing 143 deaths, while injuries were as many as 2000. About 60000 buildings suffered different levels of damage (slight to heavy). The tangible losses were roughly estimated at about 3 billions US dollars, and from this point of view it was the

The works of art were severely damaged by overturning or sliding and impact. The main reason for their failure was the fact that they were not anchored.
