SEISMIC STRENGTHENING OF THE HISTORIC CHURCH OF STs HELEN AND CONSTANTINE IN PIRAEUS

Constantine C. Spyrakos^{1*}, Panagiotis D. Kiriakopoulos², Eleni Smyrou³

Department of Civil Engineering, Earthquake Engineering Laboratory (LEE), National Technical
University of Athens (N.T.U.A.), Zografos 15700, Athens, Greece

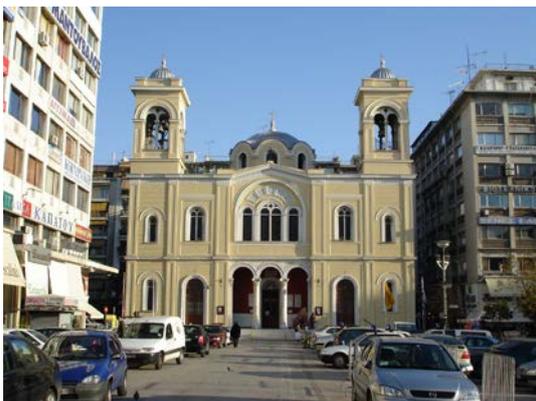
Figure-1: Front view of the temple

From an architectural perspective, the temple is a “domed basilica”. Its dome is carried on four concave triangular pendentives that serve to the transition from the circular base of the dome to its rectangular base. The weight of the dome passes through the pendentives to four massive piers at the corners. The length of the temple is 29m and the width is 23m. The total height of the temple is 23.4m with the dome and the bell towers being 7.2m and 8.6m high, respectively.

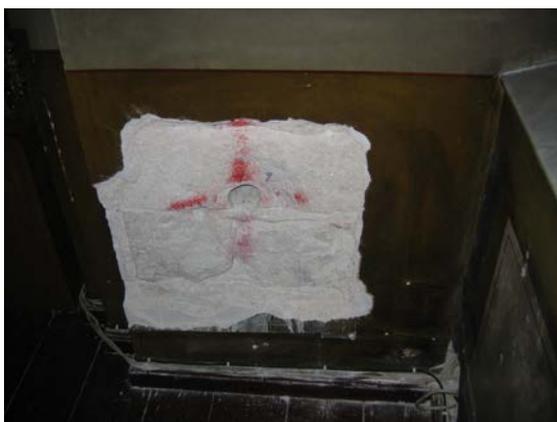
Figure-5: Area without mortar cover

At three characteristic locations of the church, the external cover of the masonry was removed at square surfaces of 50x50cm (Fig.5); two of them on masonry walls and the third on a pier. Subsequently, the stone strength was measured using a rebound hammer that was

In order to identify the transversal orientation of the materials constituting the masonry walls, drill cuttings were made and with the use of an endoscope the interior layers of the wall were inspected (Fig. 5-6). Results showed that the masonry walls are comprised of three layers. The external layers are stone of 25-30cm thickness. Moreover, the internal layer consists of solid mortar and small diameter stones.

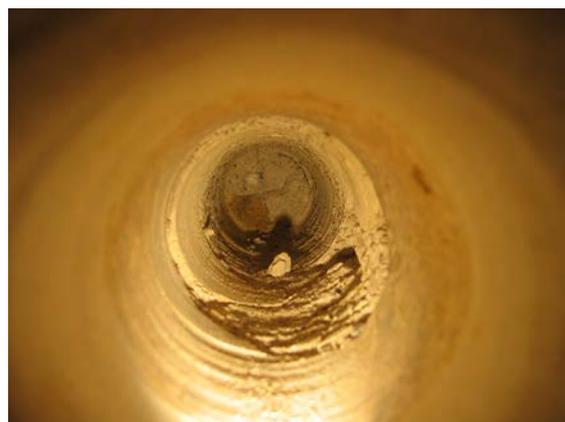
Figure-6: Inside the drill cutting

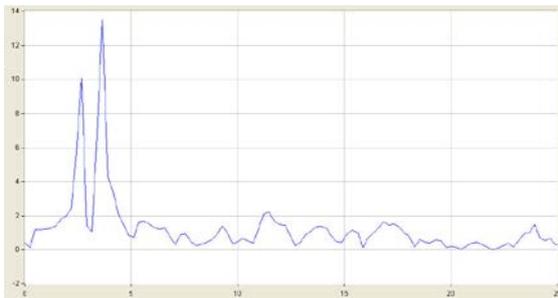
Figure-9: Deformation function at transverse direction x-x'

To measure modes and natural frequencies of the church in its present state, ambient vibrations tests were conducted. In order to fulfill the task of the tests, there were measurements in two distinct positions, ground floor and dome level, along two directions. The results are presented in the following Tables (a) and (b) as they are obtained from the peaks in figures 9 and 10.

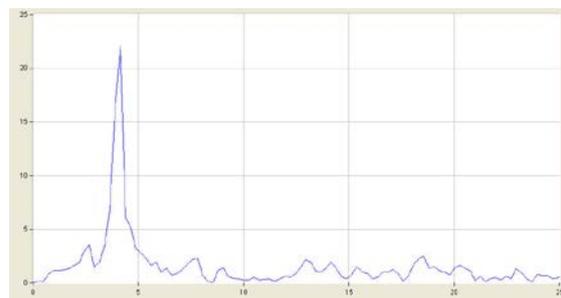
Figure-10: Deformation function at longitudinal direction y-y'

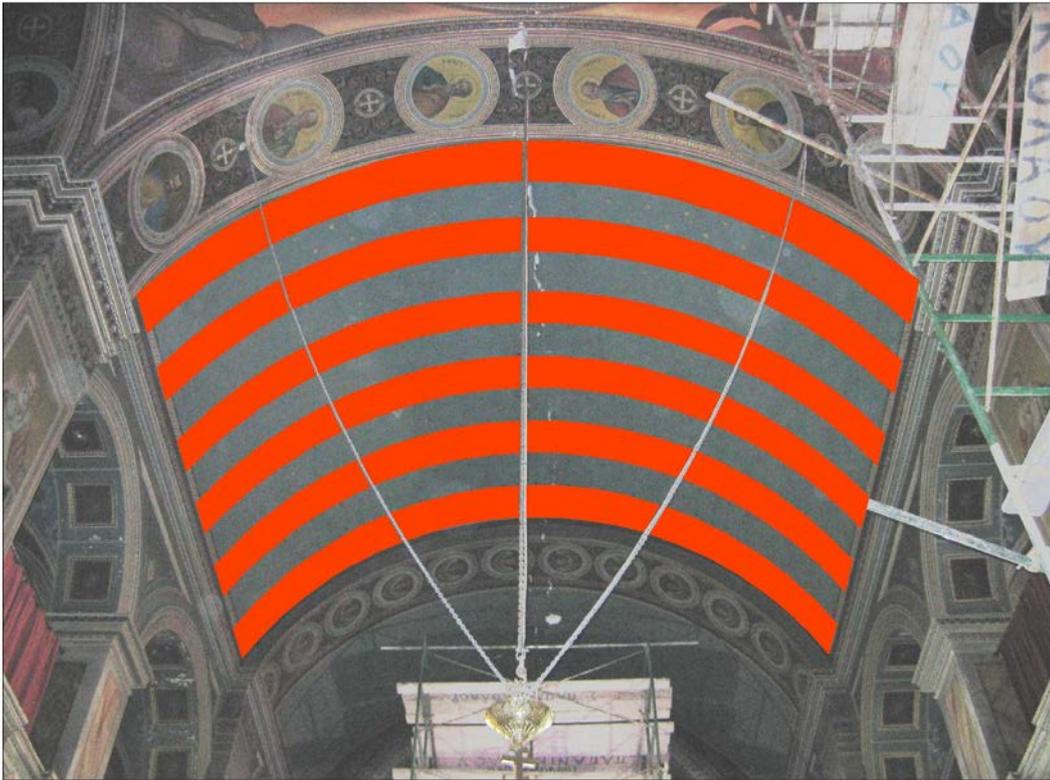
Figure-15: Placement of CFRP on the intrados of the arced ceiling

According to the analysis, undertaking of the tensile stresses can be achieved by applying sheets of fiber carbon impregnated with epoxy resins on the upper exterior surface of the church (roof) as well as at parts of the interior surfaces of certain vaults that are not decorated with historic paintings. Specifically either three or two-ply of carbon fiber reinforced plastics (CFRP), with a carbon sheet thickness of 0.17 mm is selected. The mechanical properties of the carbon fiber are: modulus of elasticity $E_c = 240$ GPa, ultimate strength $f_j = 3500$ MPa.

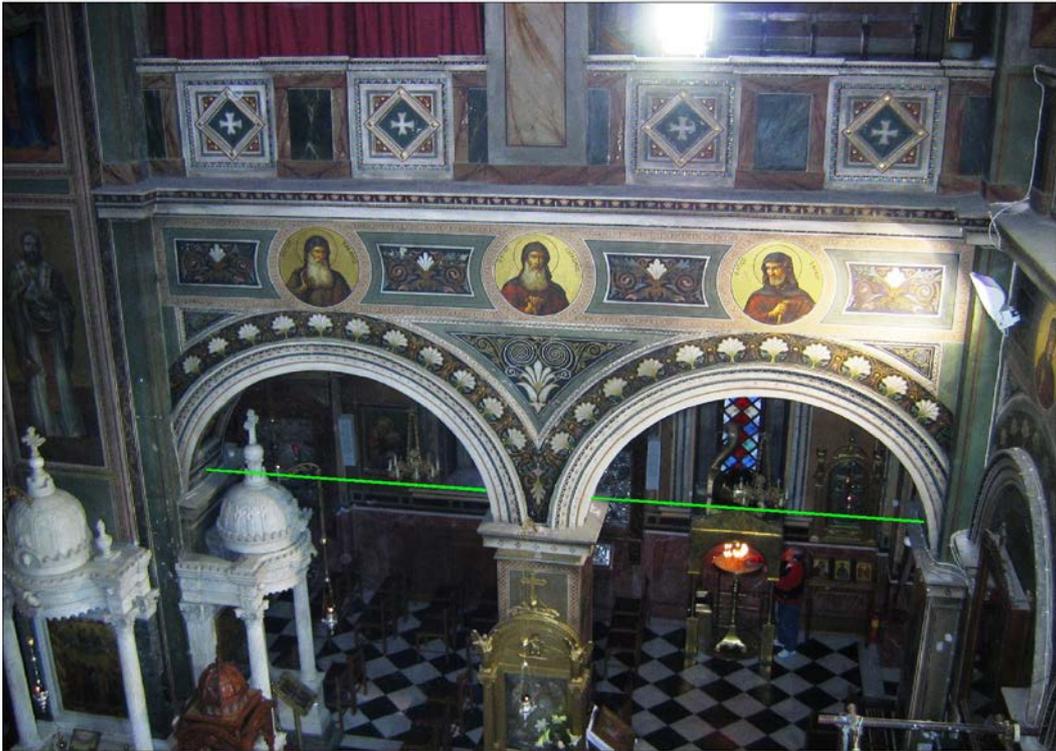
Figure-17: Placement of tie rods at arcs

Also two stainless steel tie-rods F430 with a diameter of 40mm should be placed at the upper part of the arches in the interior of the church. The mechanical properties of the tie-rods are: modulus of elasticity $E_c = 200$ GPa, yield strength $f_y = 379$ MPa, ultimate strength $f_u = 552$ MPa.
