SEISMIC EVALUATION OF THE HISTORIC CHURCH OF ST.NICHOLAS IN PIRAEUS BEFORE AND AFTER INTERVENTIONS

Constantine C. Spyrakos¹, Alessio Francioso¹, Panagiotis Kiriakopoulos¹,
and Stavros Papoutsellis¹

¹Laboratory for Earthquake Engineering, School of Civil Engineering
National Technical University of Athens
Zografos 15700, Athens, Greece
e-mail: cspyrakos@central.ntua.gr

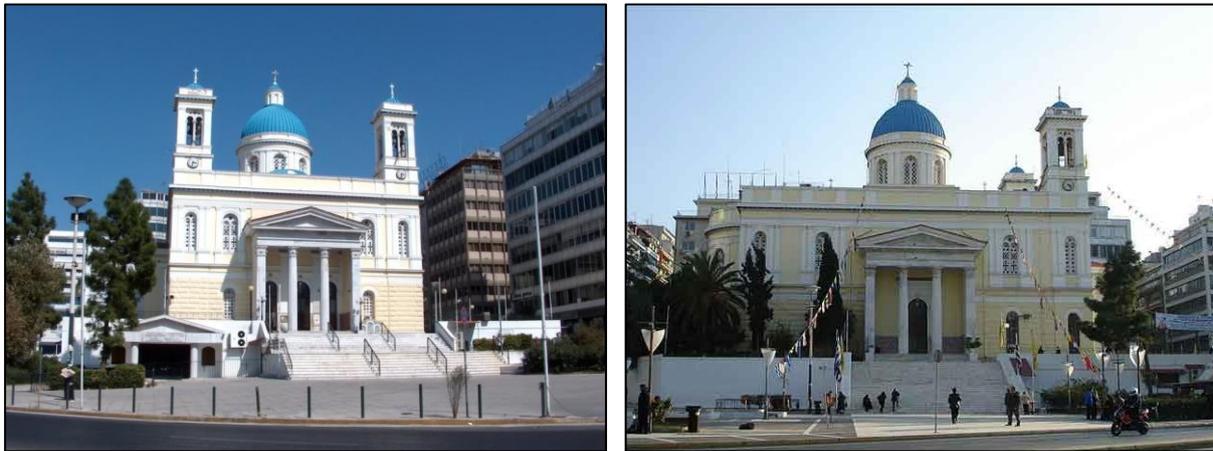
Figure 1. a) West façade and b) North façade of the church

The dimensions of the temple are 33.75m (depth) by 26.00m (length of the facade). The height of the walls is 16.52m. The height at the base of the dome reaches the 28m, while at the top the dome rises to 30m. The perimeter walls of the temple consist of three strata with a width of 1.30m. Generally the construction materials found in the building are stone, marble and tile.

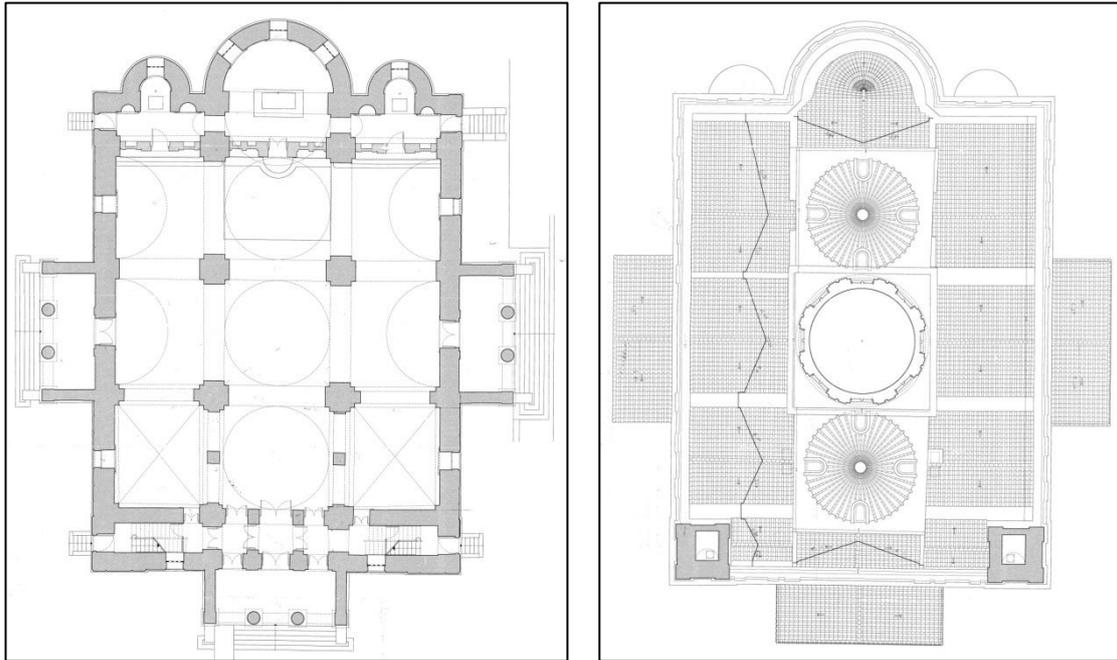
Figure 3. a) Ground floor plan. b) Roof plan

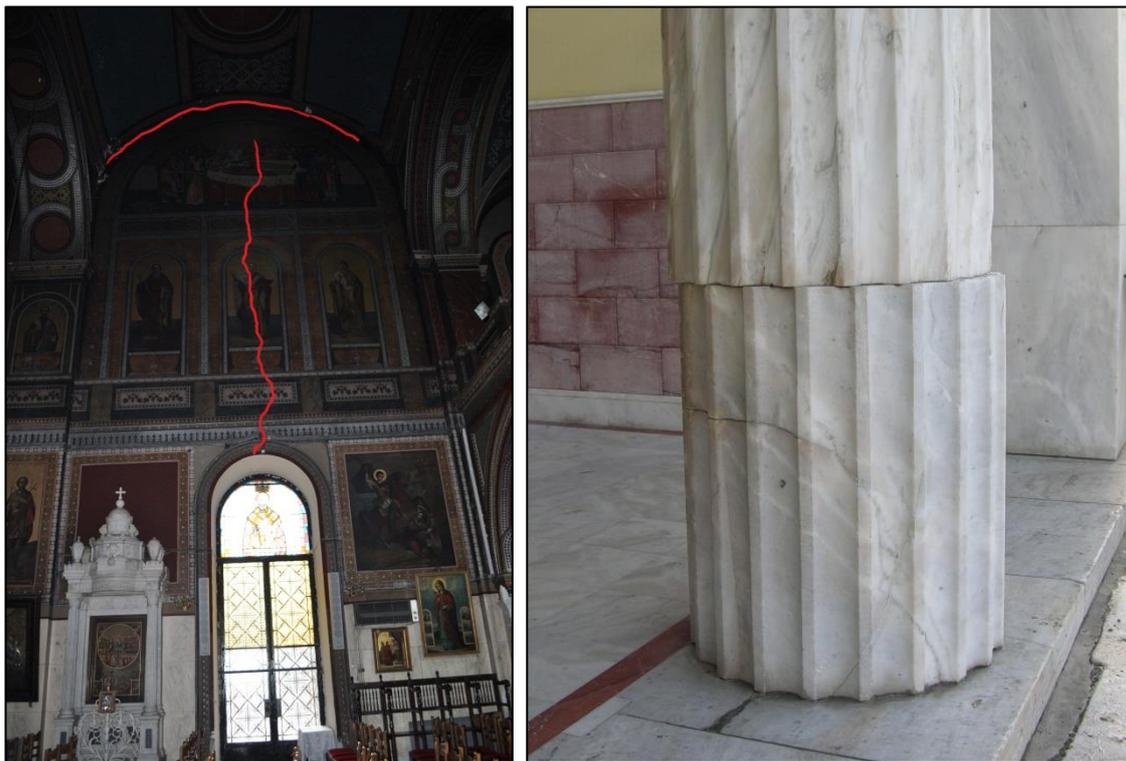
Figure 4. a) Through crack and detachment of lower drum at the southern part of the structure. b) Sliding of drum of a marble pillar caused by bombardment

Over the years the building has undergone several modifications until recent earthquakes (the Alkyonides 1981 and the Athens 1999) caused serious damages to the structure. The damages are mainly attributed to the fact that no special consideration was given in the initial design for seismic loads. Cracks appear in many parts of the masonry structure and mainly at the intrados of arches and vaults in the longitudinal and transverse directions.

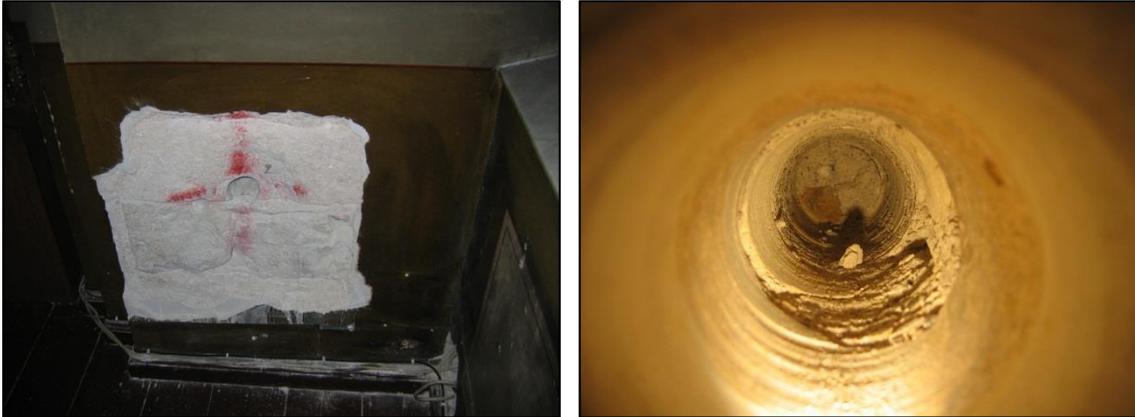
Figure 5. a) Area without plaster for inspection with endoscope. b) View inside the drilled hole

Drilled holes were opened in order to investigate by means of an endoscope the composition of the masonry walls along their thickness (Figure 5). The inspections revealed that the masonry walls were made of three-leaf masonry.

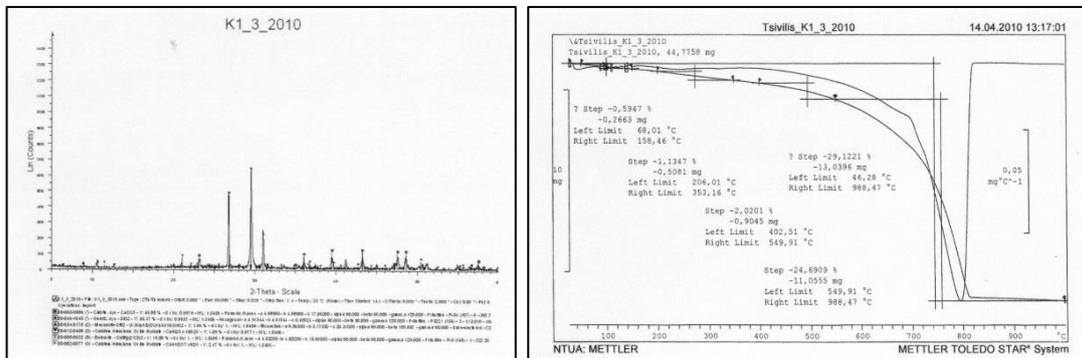
Figure 6. a) X-Ray analysis results. b) Thermal analysis results

Mortar samples were analyzed following a three-step procedure: natural separation of mortar-stone, X-Ray diffraction and thermal analysis TG-DTG (Figure 6).

The measurements and their analysis showed that: (i) the mortar contains natural hydraulic lime; (ii) the aggregate is a mixture of limestone, dolomitic and silica sands; (iii) the mortar contains muscovite.

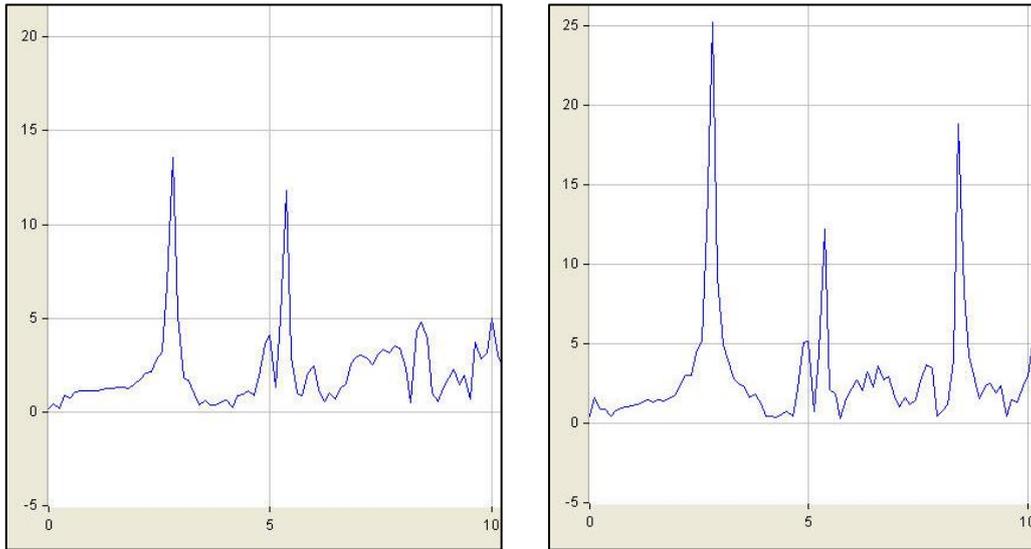
Figure 7. Transverse direction X (N-S): a) at mezzanine; b) at dome level

Table 1 presents the peaks of the Fourier spectra (see Figure 7) obtained from the ambient testing measurements.

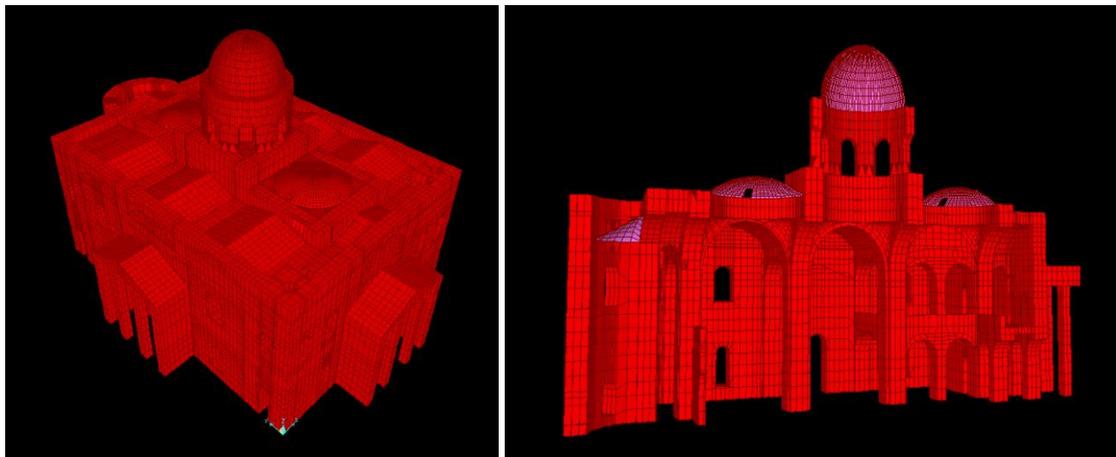
Figure 8. Three dimensional model: a) N-W view b) E-W section

The structural model and the global analysis of the structure were performed with the finite element software SAP2000 v.15 [3]. The stone masonry and marble elements were modeled with eight node solid elements with three degrees-of-freedom per node, while four-node shell elements were used to model the central dome. Frame elements were used for the proper connection and collaboration of solid and shell elements [4]. The final model consists of 42180 solids, 3350 shells, 96 frame elements and 63580 nodes, see Figure 8.

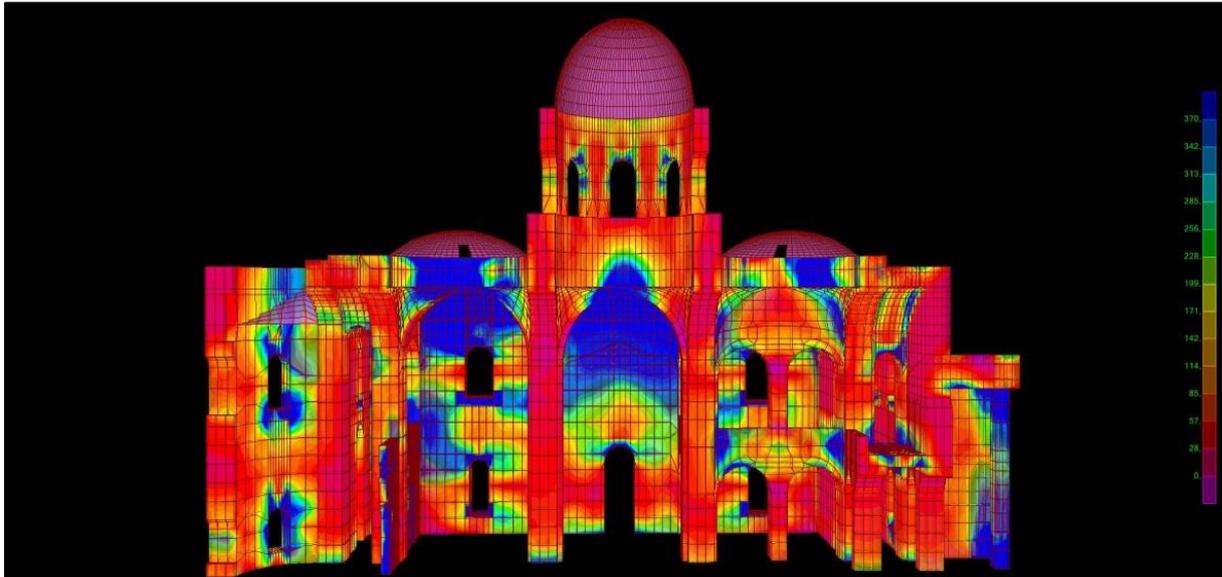
Figure 9. Stress distribution S22 for the $E_x+0.3E_y+0.3E_z$ combination

The representative Figure 9 shows the stress distribution for a seismic combination. Deep blue (darkest color) indicates the areas where the developed stresses are greater than the tensile strength of masonry. A detailed presentation of the results and the corresponding figures are provided in [7]. It is worth noting that the analysis identified with good accuracy the areas where critical damages were identified from the visual inspection.

Comparison between Table 3 and Table 5 clearly indicates the decrease of the modal periods after the interventions. According to the results of response spectrum analysis applied to the strengthened structure, it was observed that excess of the tensile strength (10% of the compressive strength of masonry) is limited at "secondary" places of the masonry walls for the seismic load combinations. Figure 16 showing the stresses after interventions corresponds to Figure 9.

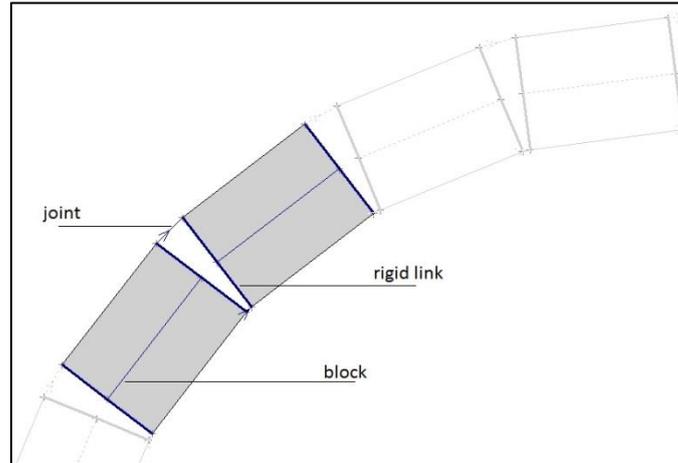
Figure 10. Structural model of an arch

A realistic approach to analyze these systems is to model the arches as a set of blocks and joints. The approach is known as the “blocks and joints” method [9]. As shown in Figure 10, both blocks and joints are frame elements: the blocks have the mechanical properties of the stone and their cross section is the effective cross section of the arch, the joints represent the mortar between the blocks. Four joints for each block are used; therefore, the joint cross section is $\frac{1}{4}$ of the arch cross section. The joints have a pin-end and a fixed-end, the fixed-end provides continuity with the previous block, the pin-end transfers shear and axial force to the next block, while the joints are connected to the block ends through rigid links; in this manner the system transfers moment, shear and axial force from one block to another.

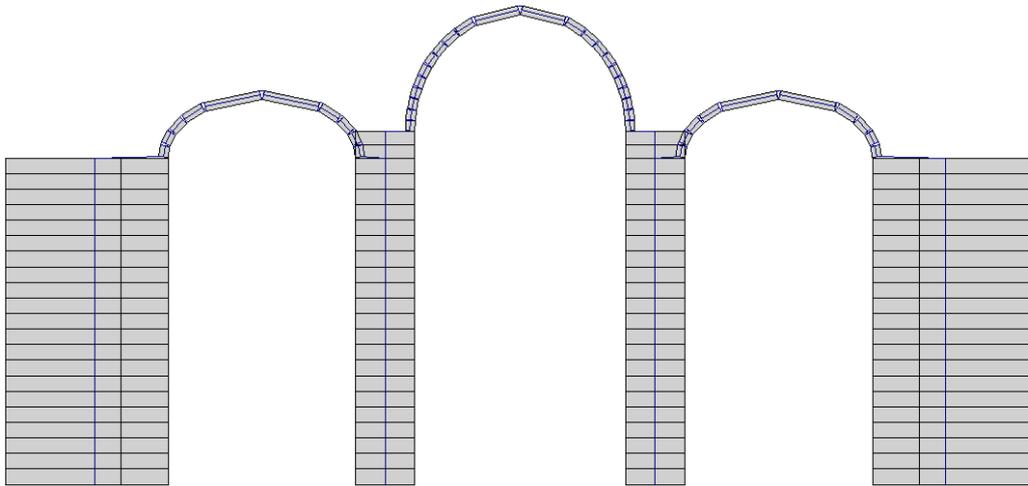
Figure 11. Structural model of the analyzed macroelement

The analyzed macroelement consists of three arches and four piers arranged along an alignment in the transverse direction of the church. The model and the analysis were performed with the aid of the software Aedes PC.E [9]. The model shown in Figure 11 consists of 604 frame elements and 488 nodes. For each node the rotation around the vertical Z axis is restrained, while the nodes at the base of the piers are fully fixed.

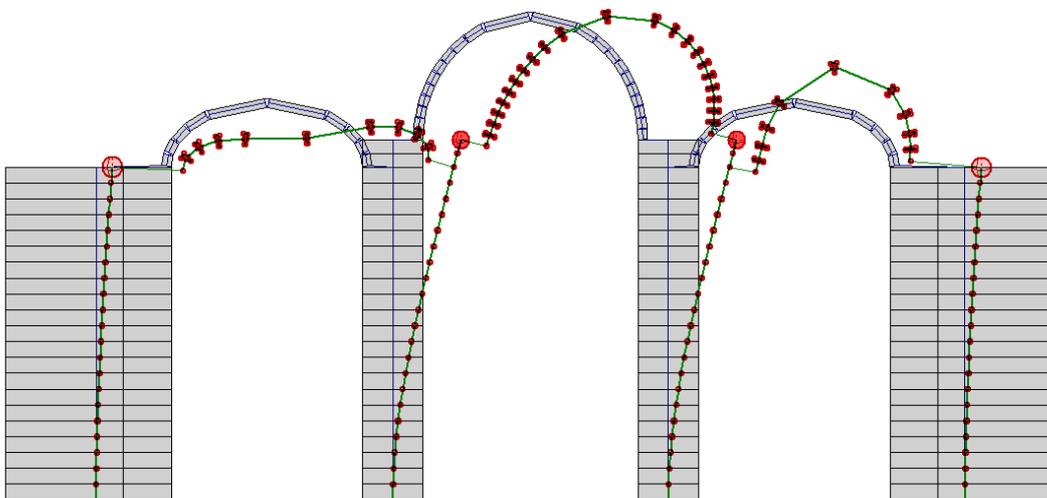
Figure 12. Deformed shape of the fundamental mode of vibration

Figure 12 shows the deformed shape of the first mode of vibration, with the red spheres representing the mass associated to each node. The fundamental period of the structure is 0.544 s and the associated participating mass is 58% as obtained from modal analysis.

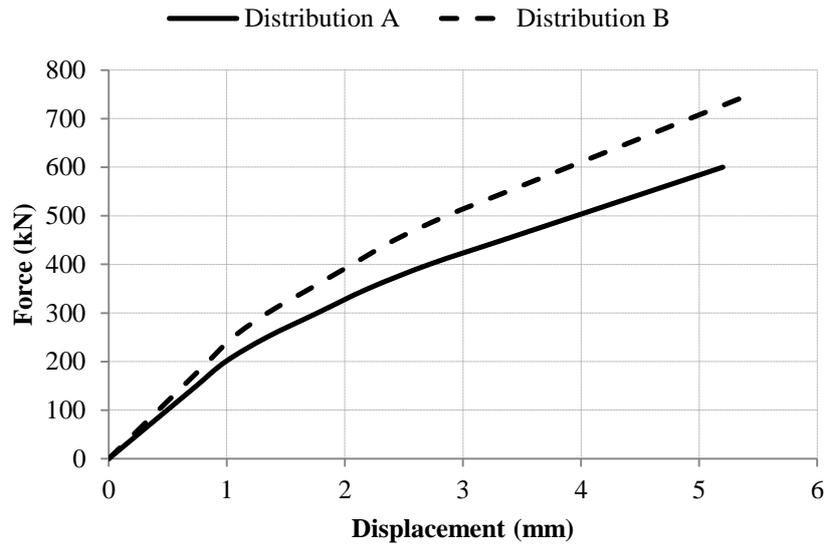
Figure 13. Capacity curves of the structure at initial state

Figure 13 shows the capacity curves of the structure at the initial state, obtained for the load distributions A and B. In the first case the structure reaches an unstable configuration for a lateral force equal to 600 kN, while with the load distribution B the maximum lateral force the structure can sustain is 750 kN.

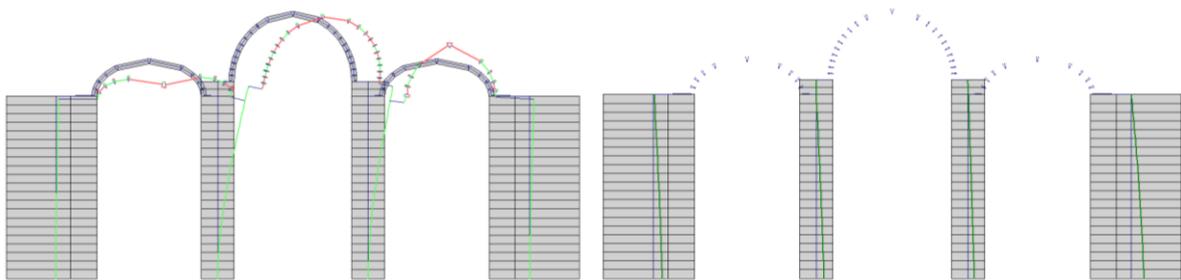
Figure 14. a) Deformed shape and b) pressure curve at last step of curve A

The results from the “triangular” distribution of the lateral forces, being more severe, will be used for safety evaluation of the structure. Figure 14 shows the deformed shape and the position of the pressure curve at the last step of the pushover analysis for the distribution A.

The deformed shape reveals the position of the plastic hinges that developed in the arches for joint degradation between the blocks. The pressure curve remains internal to the cross section of the piers; therefore, no plastic hinges develop in that area.

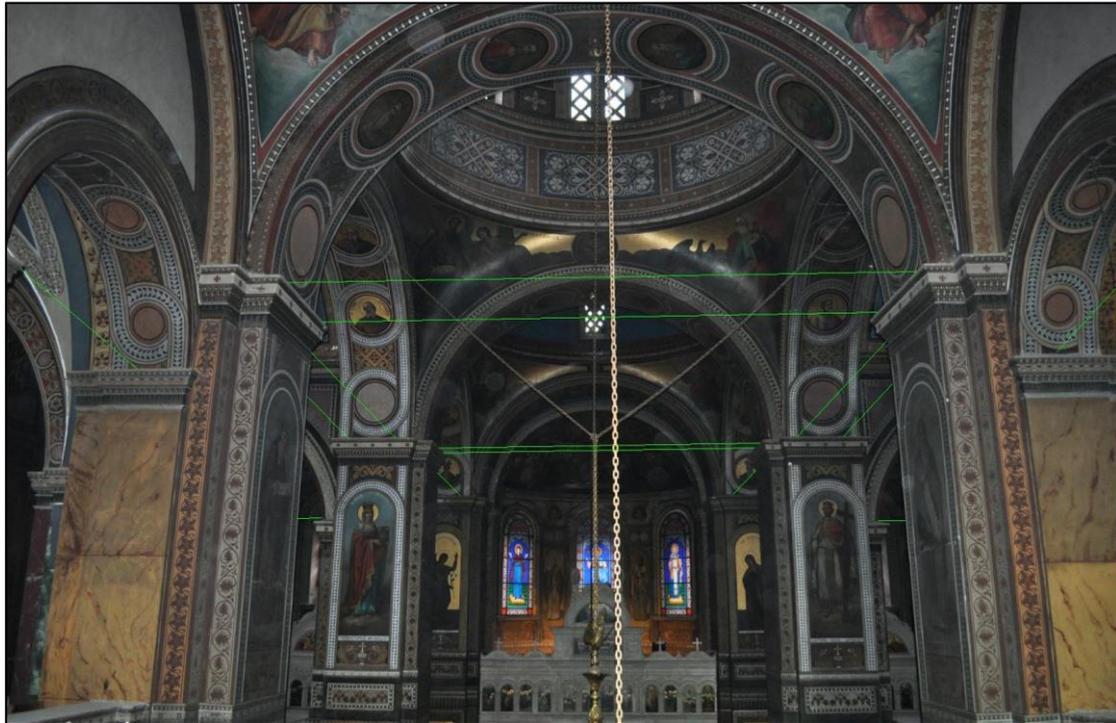
Figure 15. Position of the steel tie-rods

Also stainless steel tie-rods F430 with a diameter of 40mm were placed at the upper part of the arches in the interior of the church. The mechanical properties of the tie-rods are: modulus of elasticity $E_c = 200 GPa$, yield strength $f_y = 379 MPa$ and ultimate strength $f_u = 552 MPa$.

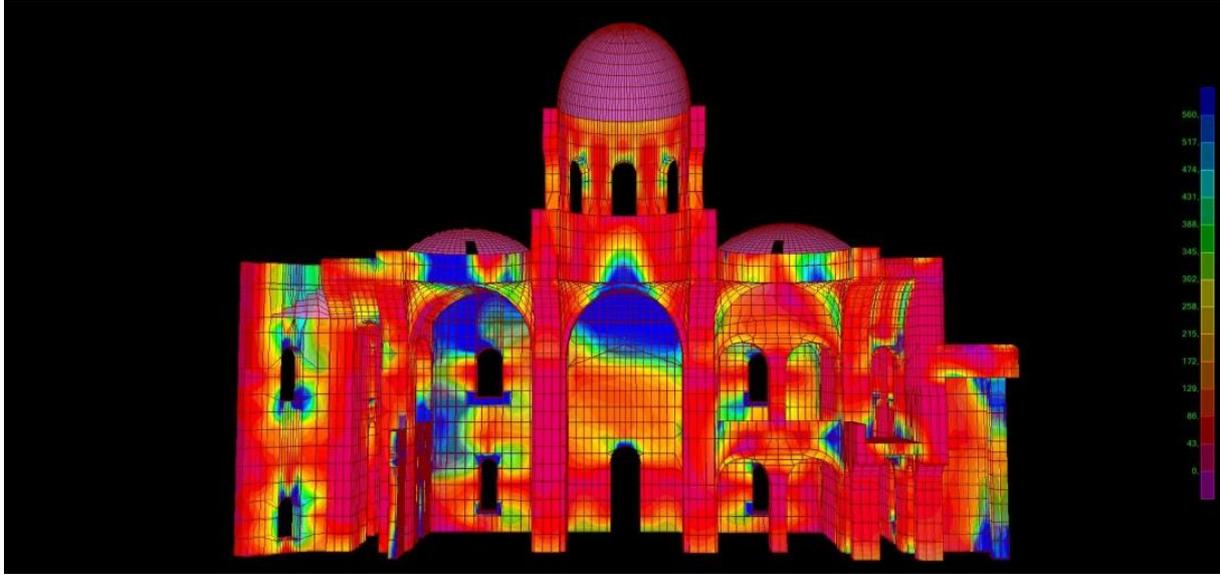
Figure 16. Stress distribution S22 for the $E_x+0.3E_y+0.3E_z$ combination
