# Performance of a post-Byzantine Triple-domed Basilica under Near and Far Fault Seismic Loads:

## Analysis and Intervention

Constantine C. Spyrakos, Charilaos A. Maniatakis, Panagiotis Kiriakopoulos, Alessio Francioso, Ioannis M. Taflampas  
*National Technical University of Athens, Greece*

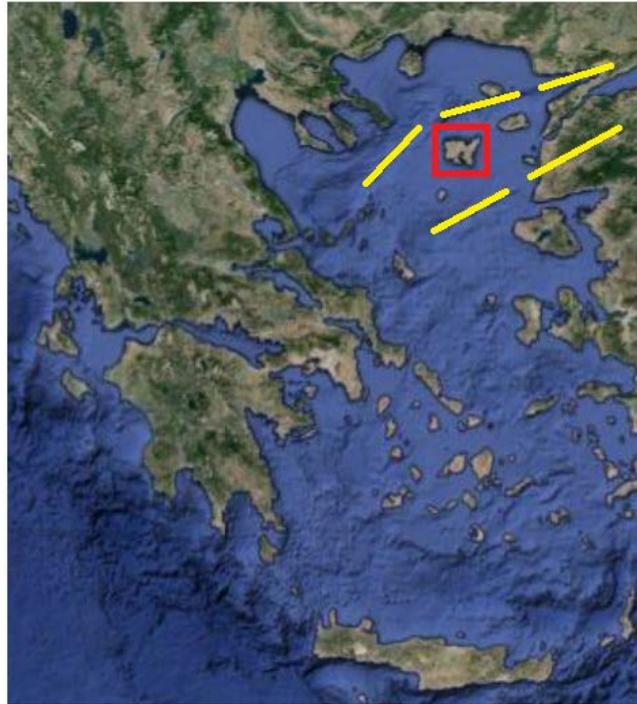
*Figure 1: Exact location of Lemnos Island in the North-East Aegean Sea. With dashed line the traces of North Anatolian fault are shown*

The 19<sup>th</sup> century can be considered as the most important period for the modern architecture for all the islands in the eastern Aegean. In the island of Lemnos, the exact location of which is depicted in Figure 1, this architectural growth has been recorded even from the travelers of that period (Tourptsoglou-Stefanidou 1986). In Figure 1, the traces of the North Anatolian fault in the vicinity of Lemnos are depicted with dashed line.

event, average shear velocity  $V_{s,30}=360$  m/sec and distance from the surface projection of the fault  $R=1$  km and  $R=5$  km, denoted as NF-1 and NF-5, respectively. The elastic spectra are depicted with a continuous line, dotted lines correspond to inelastic spectra and dashed lines correspond to mean spectral acceleration  $\pm$  one standard deviation for the NF-5 scenario. A behavior factor  $q=1.5$  was considered for all cases indicating a structure with small ductility. This value of the behavior factor is suggested by the current Eurocode 8 for unreinforced masonry structures (Comité Européen de Normalisation, 2005). The results from spectral analysis for the NF-5 scenario are not presented in detail, since as shown in Figure 11, they correspond to spectral values lower than the EC8 spectrum for the range of periods considered; thus, it could provoke less damages than the EC8 spectra. However, this overall conclusion is valid in average sense only, since consideration of the mean spectrum plus one standard deviation (NF-5 +  $1\sigma$ ) might be more damaging even from the NF-1 scenario, as also depicted in Figure 11. For clarification, it is mentioned that  $R=1$  km or  $R=5$  km indicate epicenter distances that could be in the range of 15 to 25 km. These values are indicative and could be adopted on the basis of the vicinity of Lemnos with the traces of the North Anatolian fault, as shown in Figure 1.

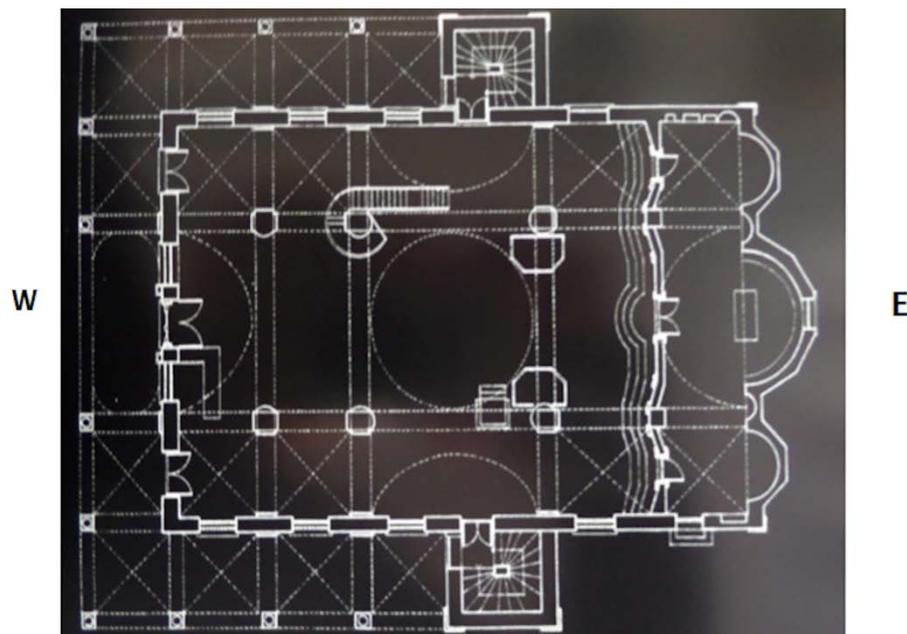
*Figure 2. Plan view of the St. Demetrius Church*

The church of St. Demetrius, located in Lemnos, has been selected as a case study of a historic structure constructed without seismic regulations in a seismically active region. It is a post-Byzantine triple domed basilica with a timber roof constructed between the years 1892 to 1902 to replace an older church (Palamida-Efthymiadou, 2007). The plan view is nearly quadrangle with three polygonal apses on the eastern façade (Figure 2). The length and width of the church are 25 and 21 meters, respectively. The central aisle has a vaulted ceiling, where a 5.6 m high dome and a Π-shaped outer narthex are incorporated. The height up to the base of the dome is 12m. The narthex maintains the typological and morphological characteristics of early Christian basilicas. The masonry construction is mixed including rubble masonry and carved corner-stones. The masonry is coated with plaster at the exterior facade of the church, while inside it is partly covered with coating and partly with frescoes. The pillars are made entirely with bricks of Byzantine type with a wooden core, as was the common practice at that period.

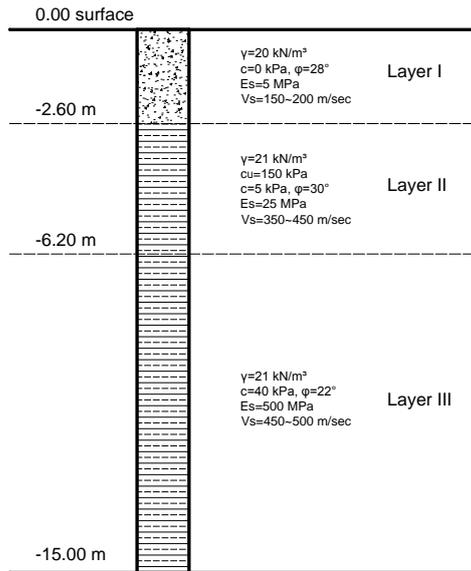
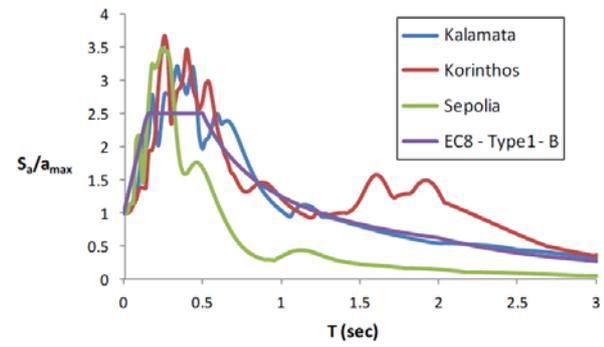
Figure 3. Geotechnical investigation: (a); soil profile; (b) amplified spectra at soil surface

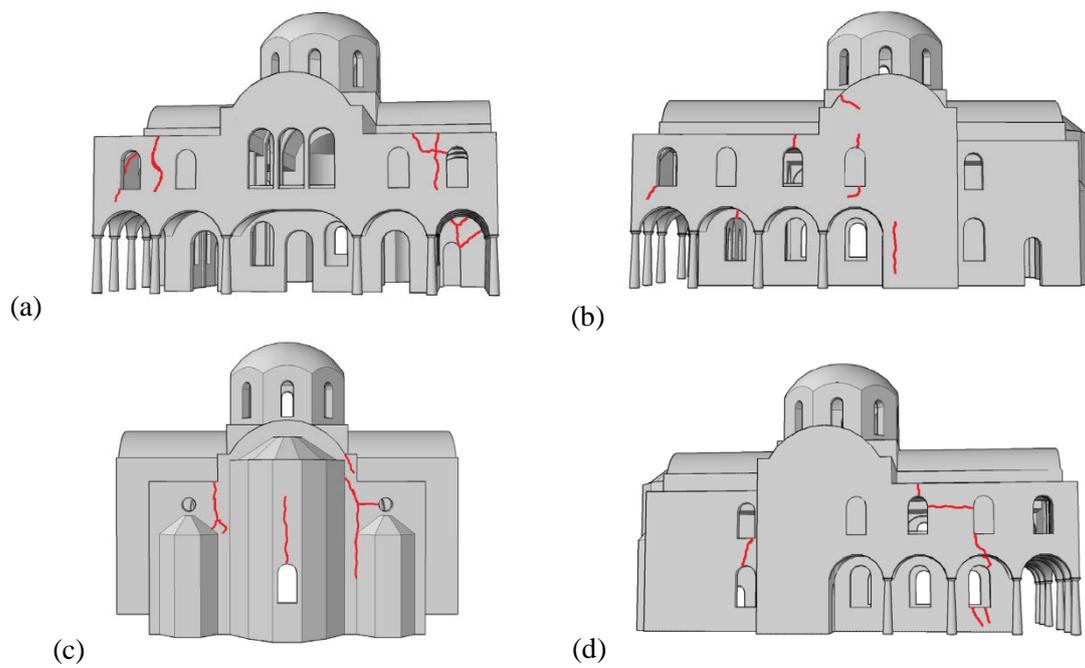
*Figure 4. Major cracks in the masonry structure: (a) frontage (west façade); (b) south façade; (c) east façade; (d) north façade*

A preliminary assessment of the condition may be performed with visual inspection and surveying which are usually applied to record damage, i.e., cracking, peeling or other imperfections in the structure. Noticeable cracking, observed almost everywhere on the internal and external facades of the Church, was recorded in detail and classified according to its type and size. Four major cracks developed in two diametrically opposed positions were observed, one at each external facade. Traces of the cracks are visible at the roof of the church; thus, it may be considered that they extend through the total height of the Church. The trace of these cracks appears to continue internally up to the vaults of the mezzanine. This crack pattern was more intense at the western façade, a trace of which could be seen on

the roof. Furthermore, most of the cracks observed on the ground floor have a trace on the parapet of the mezzanine. In Figure 4 the location and the shape of the crack pattern is depicted in all views of the structure. It should also be noted that significant cracking was also recorded at the vaults and the pillars.

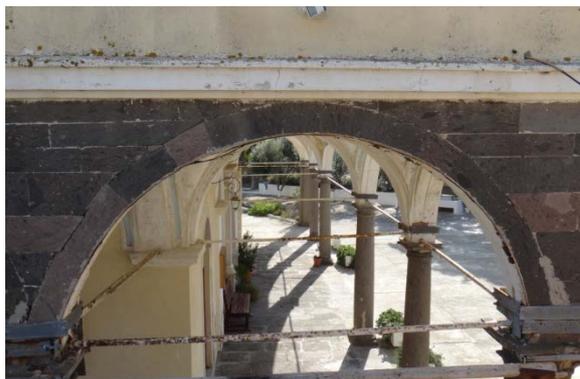
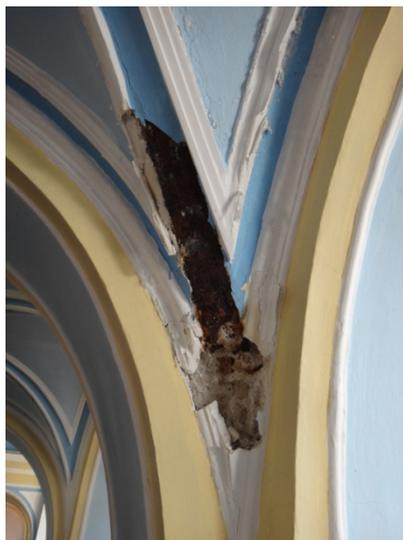
*Figure 5. Signs of corrosion: (a) external tie-rods at the west façade; (b) fully corroded steel plate supporting a cross-vault*

The internal tie-rods are manufactured by steel blades with different dimensions while the external rods have square hollow sections with external dimensions 3 cm x 3 cm. Advanced signs of oxidation have been observed on the external tie-rods while the interior ones present a much better condition. However, they are not placed continuously in each aperture and they do not have adequate anchorage; thus, their contribution should not be considered under seismic excitations.

At the bottom surface of the cross-vaults there exist oxidized and partially detached steel plates, as shown in Figure 5(b). Furthermore, one of the pillars in front of the temple has been strengthened with a reinforced concrete jacket, implying some local failure. The existence of local retrofit measures supports the supposition that the church has experienced damage in the past.

Carbon polymer reinforced strips are also placed at the bottom surface of cross-vaults to replace the existing steel plates, as shown in Figure 21(d). The CFRP strips combine high durability and fire resistance with significant strength.

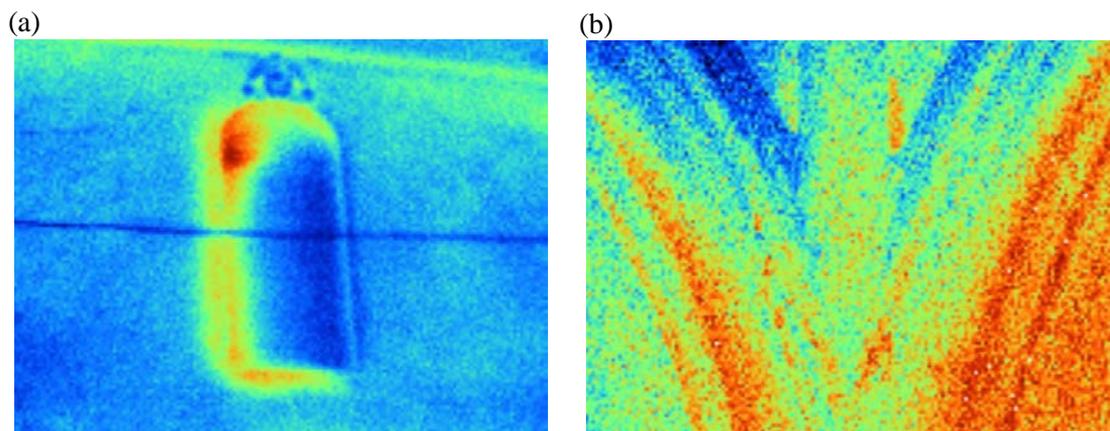
*Figure 7. Results of Infrared Thermography method at selected locations: (a) moisture detection near a closed window; (b) humidity detection at the base of a cross-vault*

An infrared radiation source is placed on one side of the control element and the flow of infrared energy is recorded and analyzed (Titman, 2001). Any gaps or inconsistencies in the body of masonry disrupt the flow of radiation and can thus be detected. This method is mainly used to detect corrosion, internal cracks, gaps, increased porosity and changes in materials of masonry of layout. Results of the method of Infrared Thermography at selected locations may be seen in Figure 7. Application of the method revealed areas of humidity at the walls and confirmed testimonies and historic data about the absence of either partial or full closure of openings.

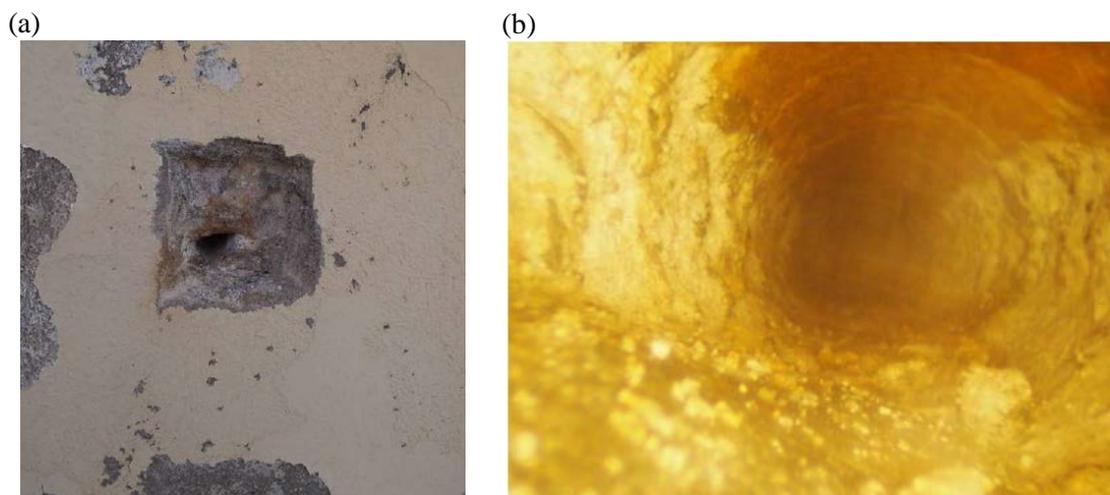
*Figure 8. Endoscopy at the external wall next to the southern main entrance in the west façade: (a) drilling of the inspection hole; (b) interior view*

It was found that the bearing walls are composed by three-leaf masonry. There is no uniformity in the layout since stones of different sizes have been used at several locations. The stones are generally not carved while bricks are used mainly for the construction of the central pillars. Between the outer leafs there is a filler layer that consists of small stones and mortar of poor quality. The limited and small gaps in the middle layer of the wall, revealed by endoscopy, are fully compatible with this construction method (three-leaf masonry construction). In Figure 8 the endoscopic testing at the external wall next to the southern main entrance in the west façade.

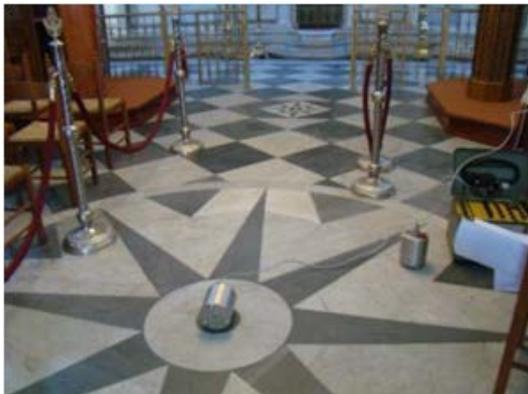
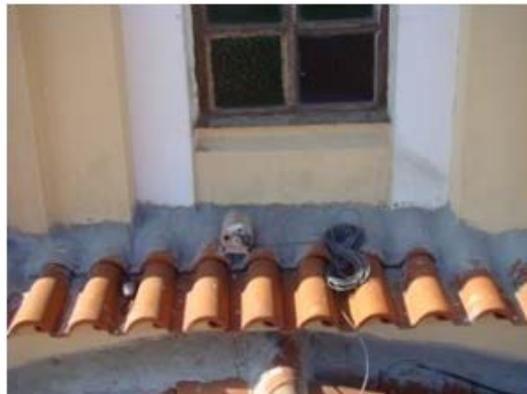
*Figure 9. Ambient Vibration testing at indicative positions: (a) ground floor beneath the central dome; (b) roof of the mezzanine*

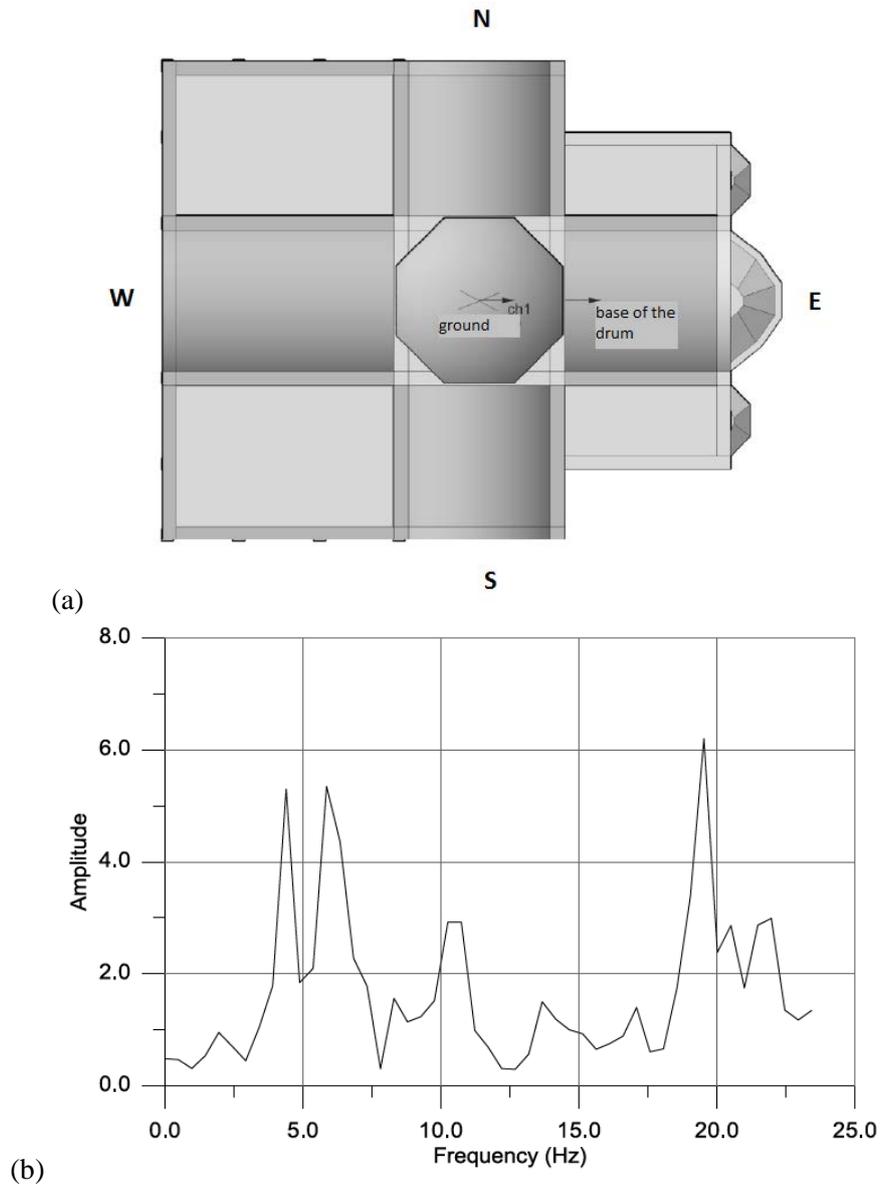
Figure 10. Ambient vibration testing in the West-East direction: (a) Placement of instruments; (b) Transfer function

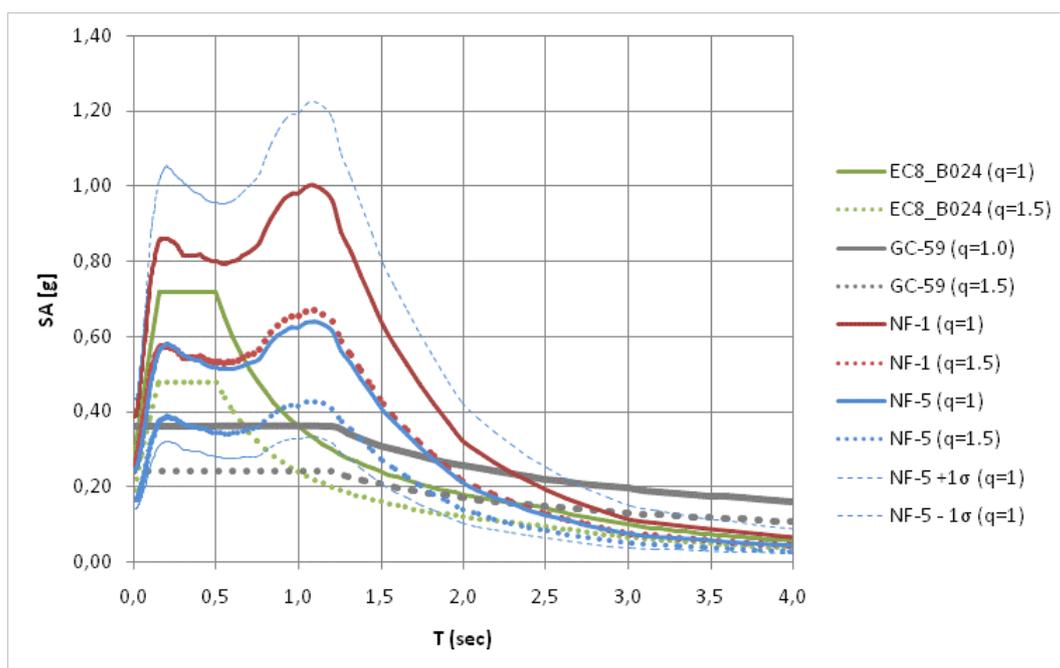
Figure 11. Comparison of different spectra applied in the analyses

As depicted in Figure 11 the maximum demand is imposed from the near-fault spectrum at  $R=1$  km, NS-1, while the second most damaging loading should be expected for the other spectrum in the near-fault area at  $R=5$  km, NS-5. Indeed the maximum stresses for seismic combinations are noticed for the NS-1 spectrum, as shown in Figures 15-18 (c) while the NS-5 seismic scenario also results in extended damage as shown in Figures 15-18 (d). The eigenperiod at each direction and the corresponding spectral acceleration for each spectrum are shown in Table 4. Notice that the West-East direction was set as direction x-x. The capacity checks included:

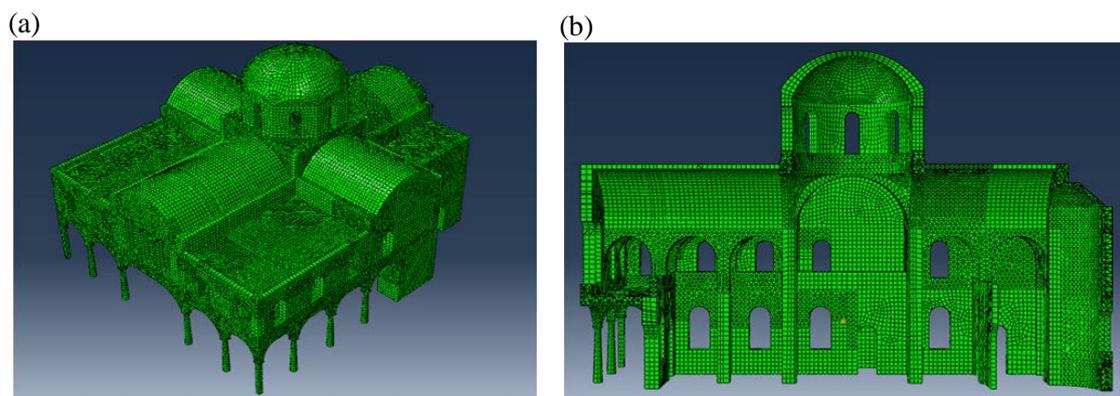
*Figure 12. General views of the finite element model: (a) three dimensional view; (b) sectional view along the west-east direction*

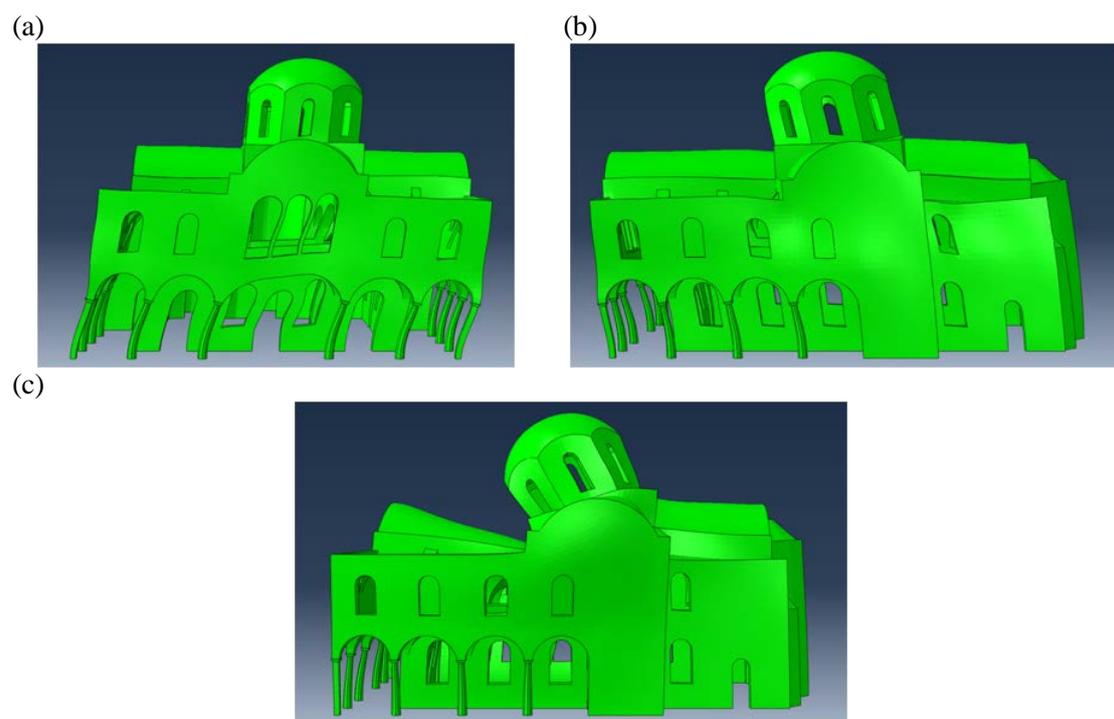
Figure 13. Eigenvalue analysis of the initial structure: (a) 1<sup>st</sup> mode of vibration; (b) 2<sup>nd</sup> mode of vibration; (c) 3<sup>rd</sup> mode of vibration.

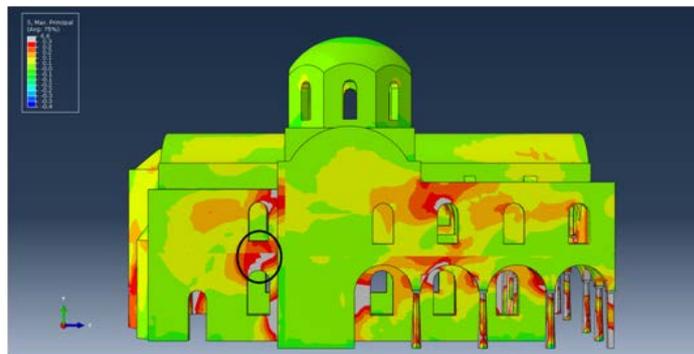
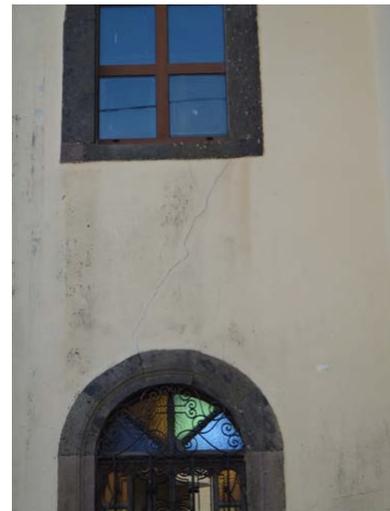
*Figure 14. Validation of the finite element model: (a) position of tensile failure at the north façade; (b) confirmation of crack existence in the same place*

Further the analytical results allowed the validation of the finite element model, since they predicted with considerable accuracy the location of major cracks observed from the surveying. A typical example of validation regarding the north façade is shown in Figure 14. The distribution of maximum stresses, for all the different spectra, are depicted in Figures 15, 16, 17 and 18 for the west, south, east and north façade, respectively. It should be noted that grey colors in the contour diagrams indicate exceedance of the tensile strength. The grey color denotes failures that occur nearly at all facades and for all cases regarding the initial structure prior to the interventions.

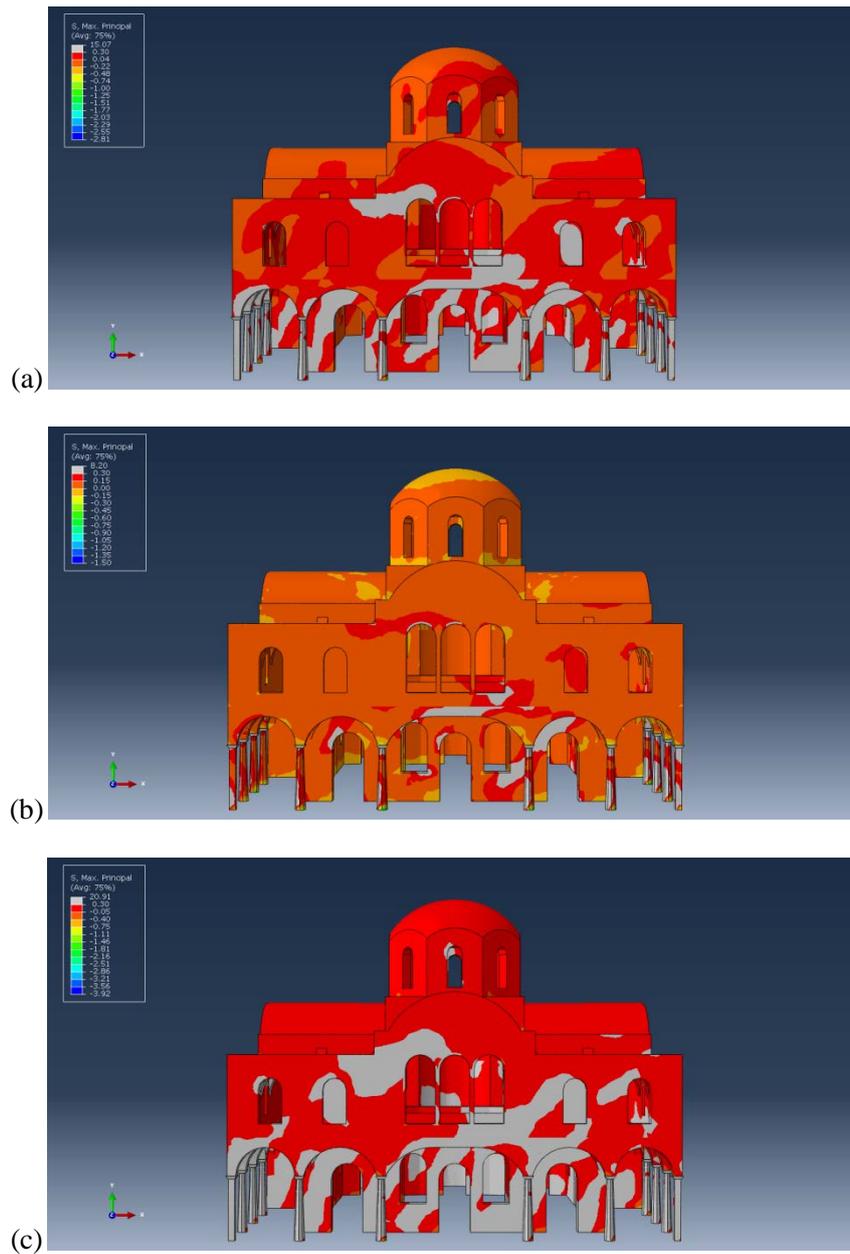
Figure 15. West façade - Distribution of maximum stresses in the original model without interventions for the  $G+0.5Q+Ex+0.3Ey$  combination: (a) Eurocode 8 spectrum; (b) 1959-Greek Seismic Code spectrum; (c) Near-fault spectrum with  $R=1$  km

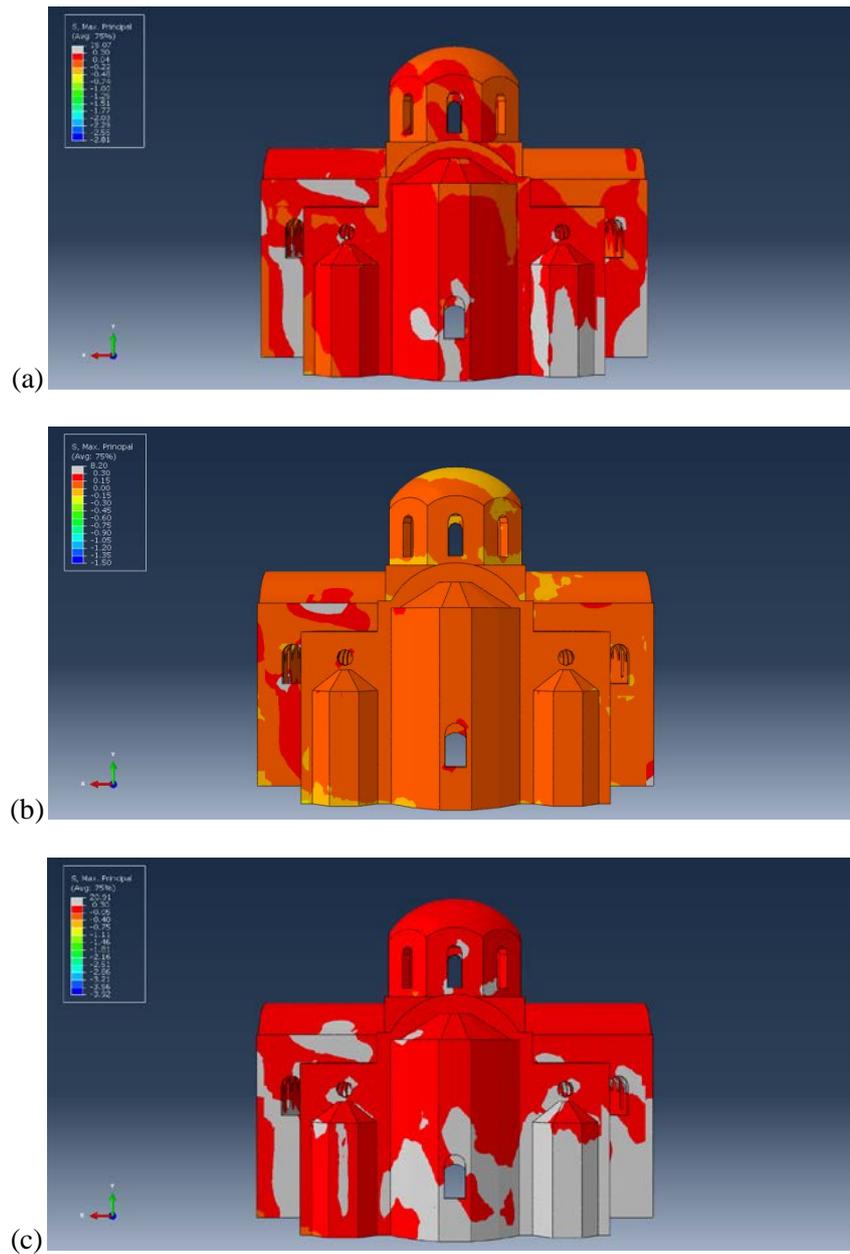
Figure 16. East façade - Distribution of maximum stresses in the original model without interventions for the  $G+0.5Q+Ex+0.3Ey$  combination: (a) Eurocode 8 spectrum; (b) 1959-Greek Seismic Code spectrum; (c) Near-fault spectrum with  $R=1$  km

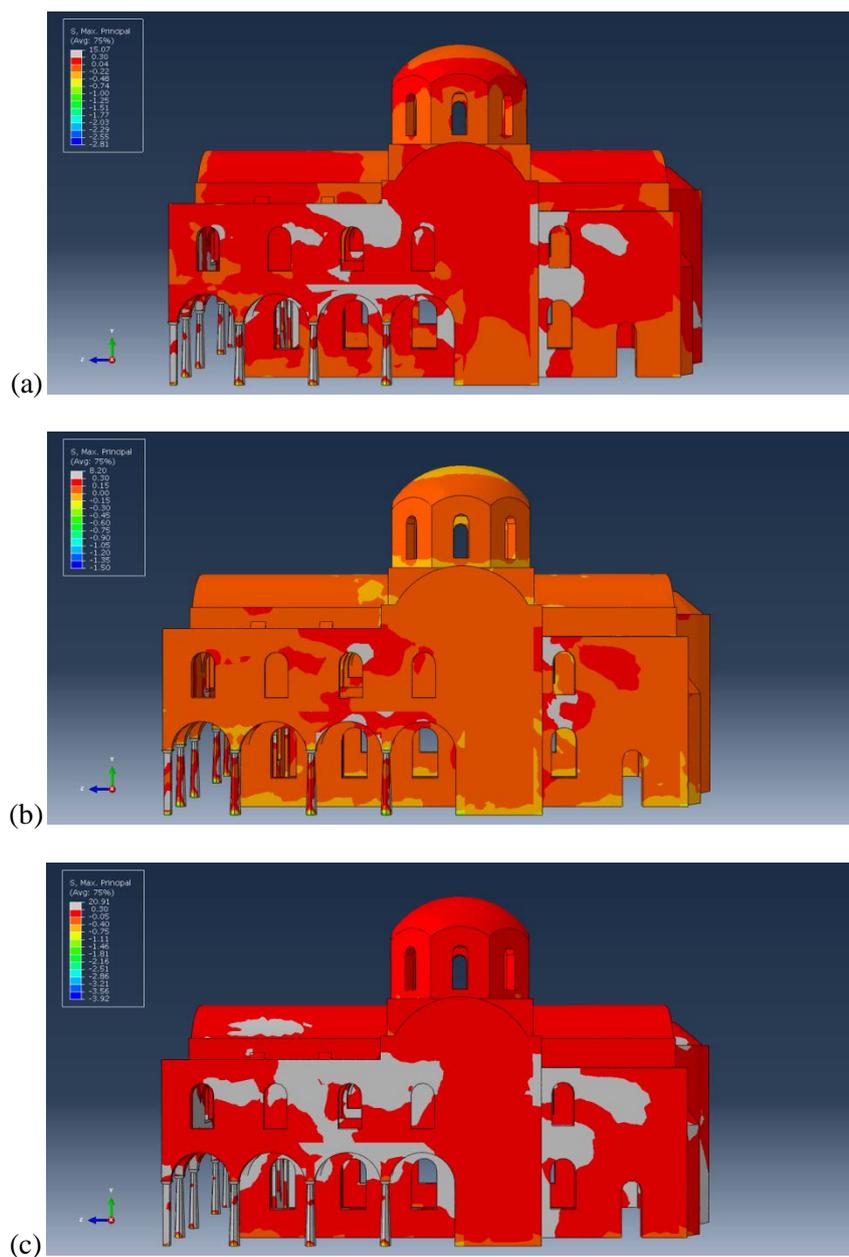
Figure 17. South façade - Distribution of maximum stresses in the original model without interventions for the  $G+0.5Q+Ex+0.3Ey$  combination: (a) Eurocode 8 spectrum; (b) 1959-Greek Seismic Code spectrum; (c) Near-fault spectrum with  $R=1$  km

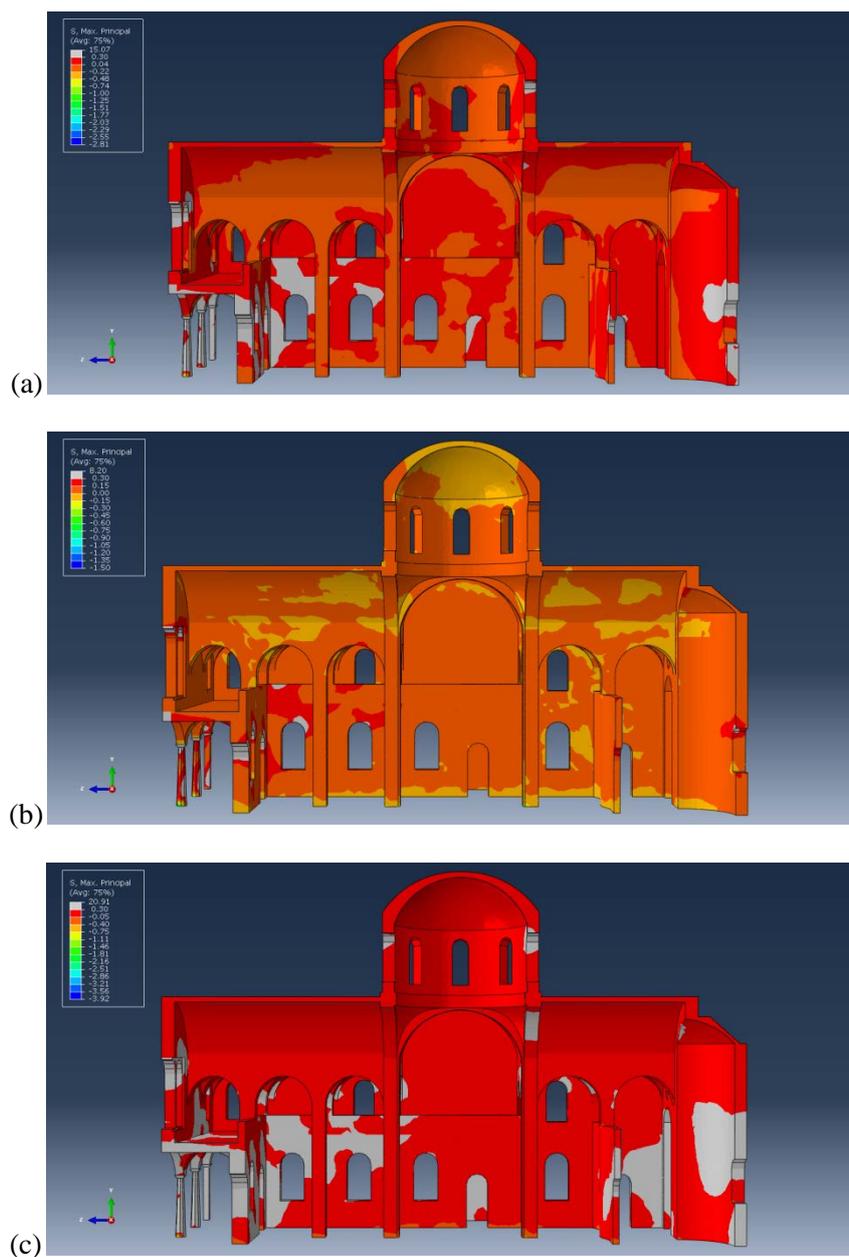
Figure 18. North internal façade - Distribution of maximum stresses in the original model without interventions for the  $G+0.5Q+Ex+0.3Ey$  combination: (a) Eurocode 8 spectrum; (b) 1959-Greek Seismic Code spectrum; (c) Near-fault spectrum with  $R=1$  km

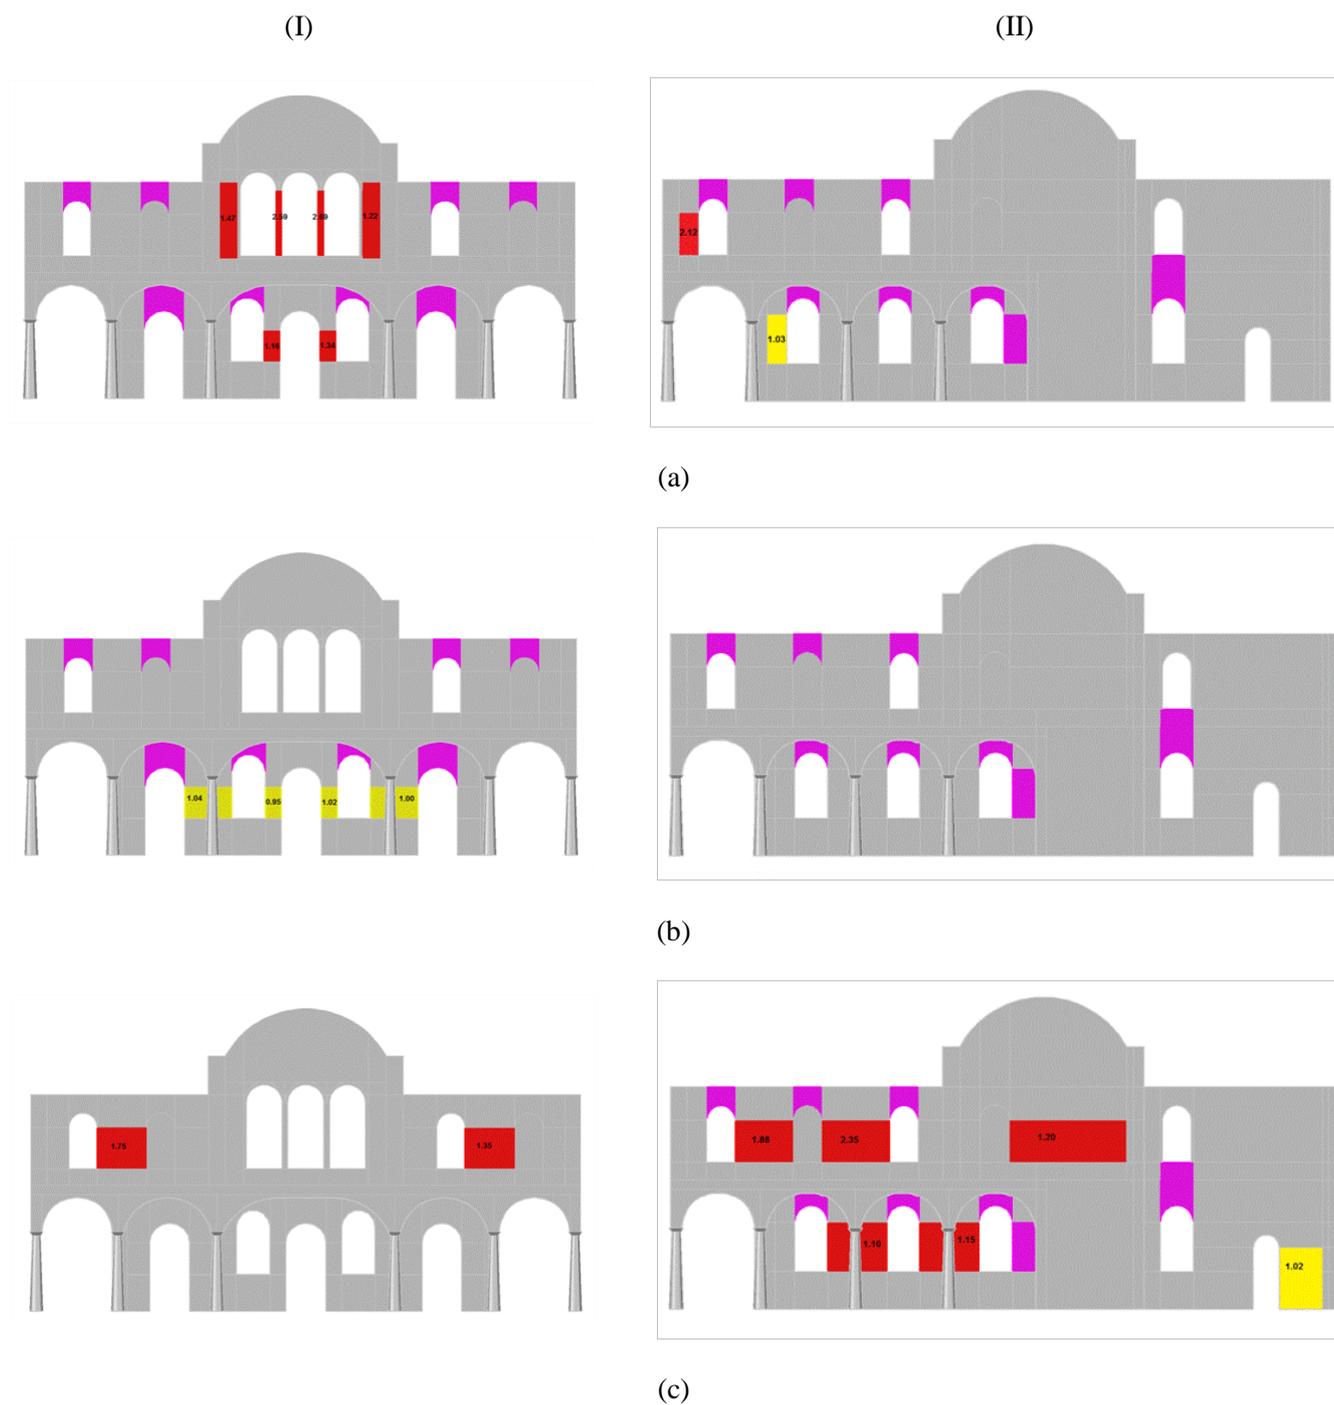
Figure 19. Failure according to capacity exceedance. Yellow color for  $0,90 \leq \alpha \leq 1,1$ ; Red color for  $\alpha > 1,1$ ; Magenta for tensile failure. (a) In-plane flexure; (b) Shear; (c) Out-of-plane flexure. (I) West façade; (II) South - north façade

Figure 19 shows the pillars and lintels that fail according to the analysis. The rate of failure is assessed based on the ratio  $a = \text{Demand}/\text{Capacity}$ . A yellow color is selected to show slight avoidance of failure or slight exceedance of the capacity when  $0.90 \leq a \leq 1.1$ . The red color depicts the elements with significant failure, i.e.,  $a > 1.1$ . Magenta denotes failure in tension.

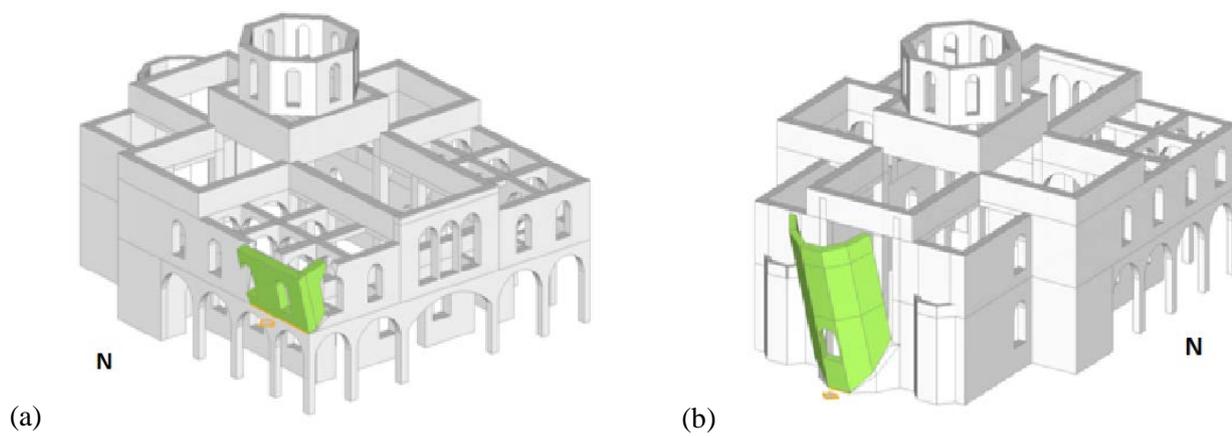
*Figure 20. Selection of different local collapse mechanisms: (a) overturning of a structural part in the north façade; (b) overturning of the central apse in the east façade*

The systematic inspection of the construction details, knowledge of the masonry typology, the presence of earthquake-resistant elements and the visual inspection of existing cracks and damages allowed to identify the structural macroelements and to foresee which collapse mechanism is more likely to develop for the St. Demetrius Church. The determination of possible collapse mechanisms allows for a study of the out-of-plane behavior through a kinematic limit analysis of these mechanisms. Given the pattern of the cracks existing on the structure, two collapse mechanisms are examined, that is, the overturning of a part of the left façade and the overturning of the central apse, as shown in Figure 20.

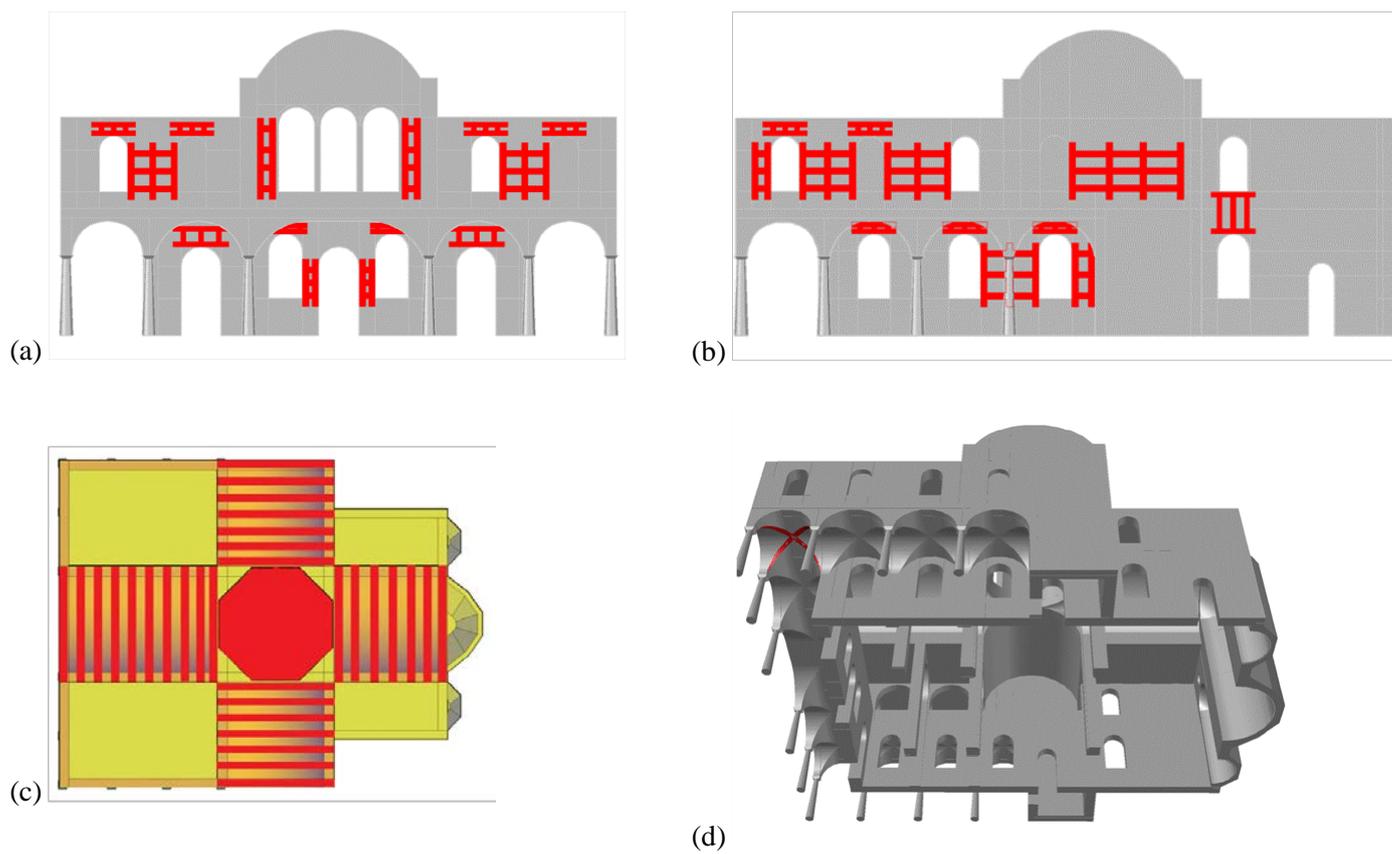
*Figure 21. Strengthening with CFRPs: (a) west façade; (b) south & north façade; (c) roof; (d) cross-vault*

are: modulus of elasticity  $E_c=240$  GPa and ultimate strength  $f_j=3500$  MPa. The tiles of the roof are temporarily removed and replaced after the placement of CFRP sheets.

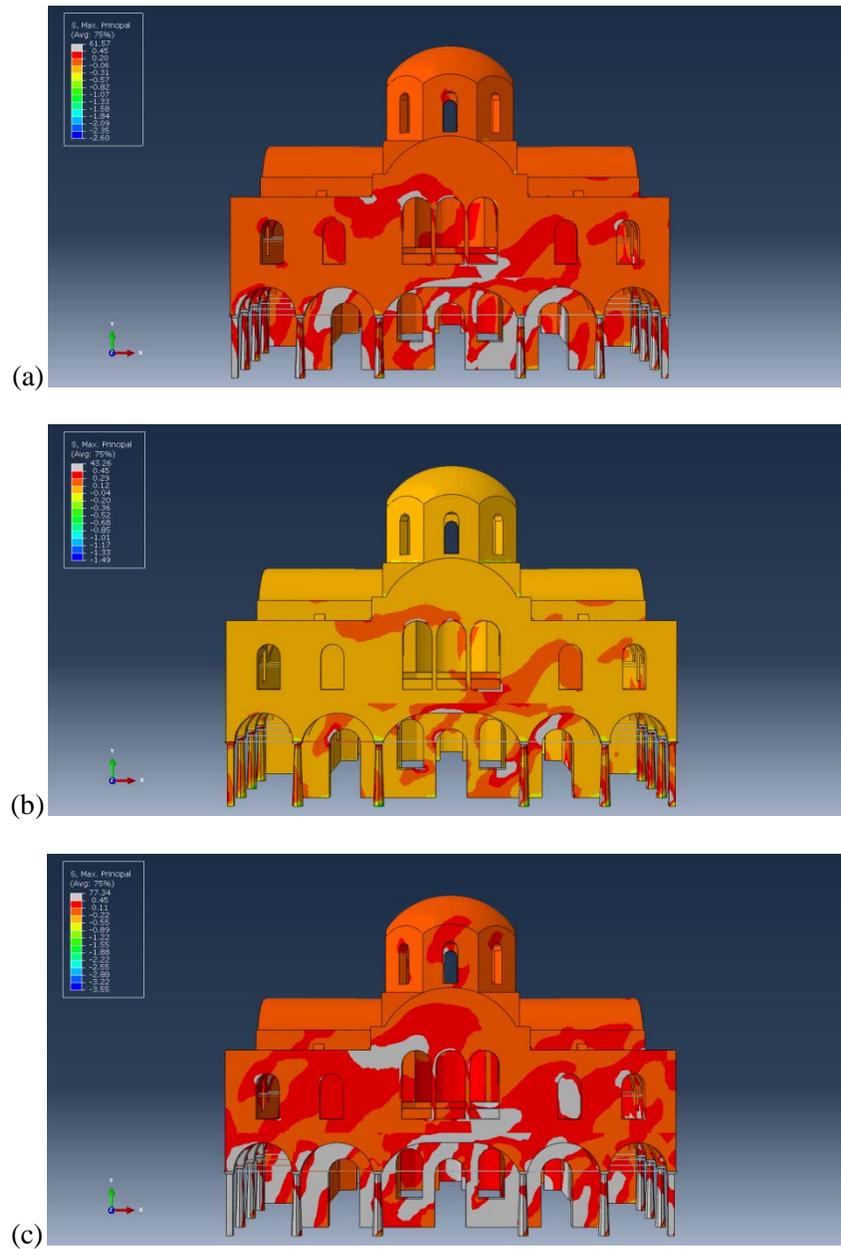
Figure 22. West façade - Distribution of maximum stresses in the strengthened model for the  $G+0.5Q+Ex+0.3Ey$  combination: (a) Eurocode 8 spectrum; (b) 1959-Greek Seismic Code spectrum; (c) Near-fault spectrum with  $R=1$  km

Modal response spectrum analysis is performed for the four seismic scenarios and the results regarding the structure after interventions are depicted in Figures 22, 23, 24 and 25 for the west, south, east and north façade, respectively. For reasons of comparison, Figures 22-25 follow the same arrangement with Figures 15-18 that correspond to the stress distribution in initial condition prior the interventions. After the application of the rehabilitation scheme the exceedance of tensile strength is limited mainly at masonry elements of decrease structural value, as regards the stress distribution for the EC-8 and the GC-59 spectra (Figures 22-25 (a) and (b)). The greater part of the façades surface is depicted with a pale color in the contour display that suggests non-exceedance of the tensile strength. Maximum displacement at the top of the dome is 13.7 mm, a value acceptable for life-safety performance.

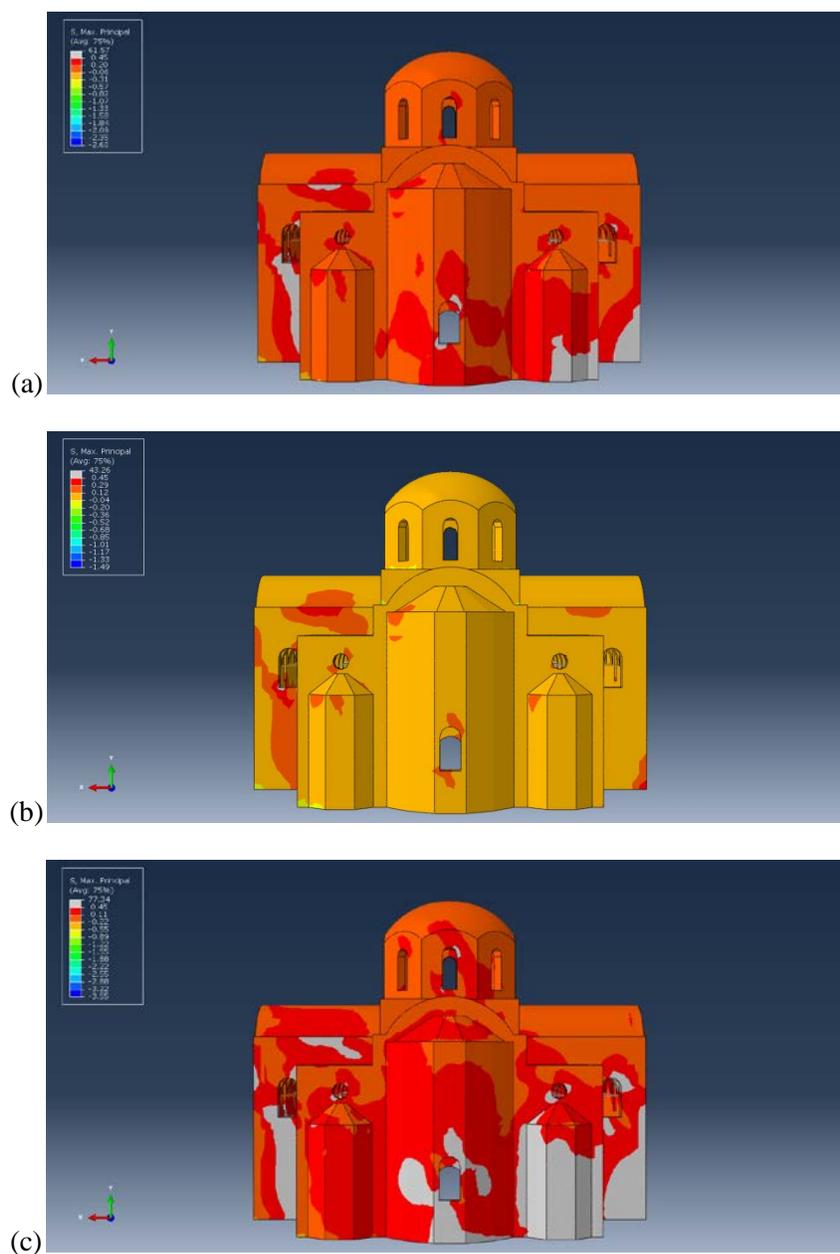
Figure 23. East façade - Distribution of maximum stresses in the strengthened model for the  $G+0.5Q+Ex+0.3Ey$  combination: (a) Eurocode 8 spectrum; (b) 1959-Greek Seismic Code spectrum; (c) Near-fault spectrum with  $R=1$  km

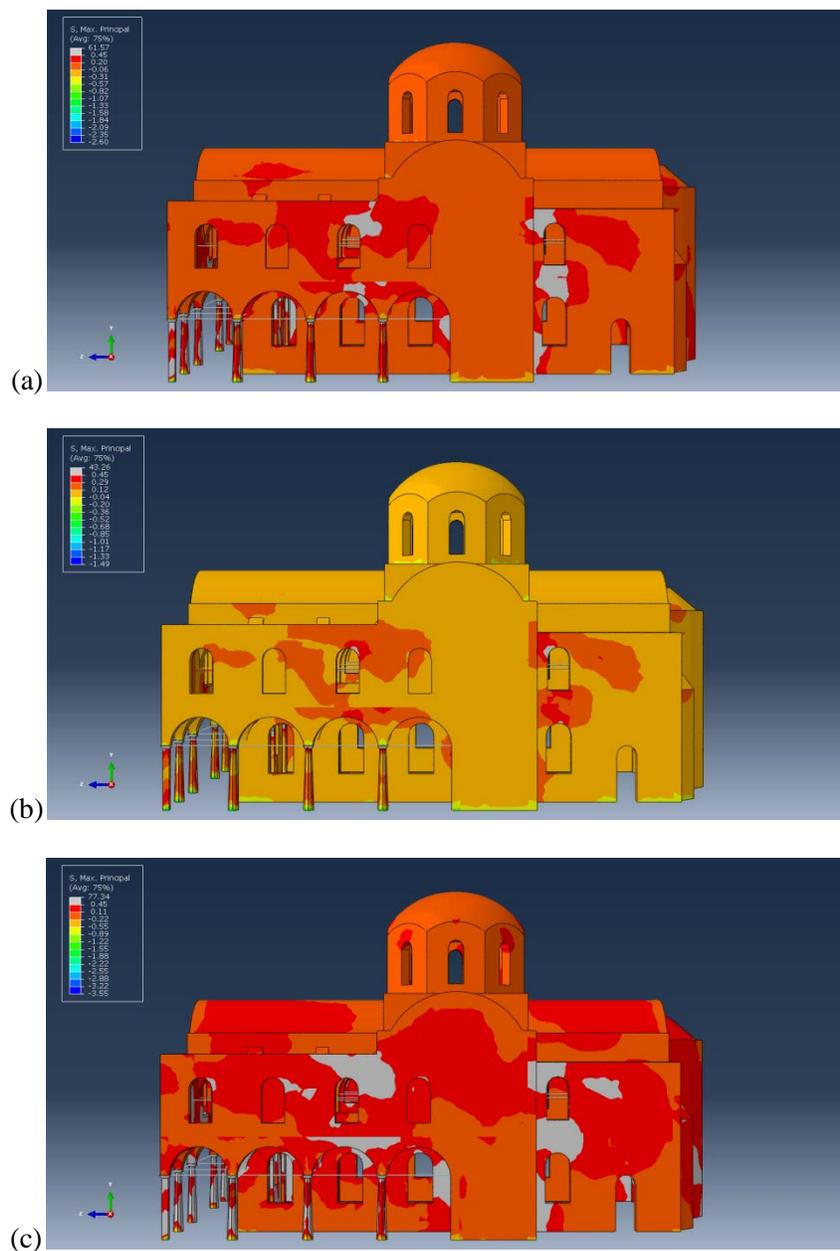
Figure 24. South façade - Distribution of maximum stresses in the strengthened model for the  $G+0.5Q+Ex+0.3Ey$  combination: (a) Eurocode 8 spectrum; (b) 1959-Greek Seismic Code spectrum; (c) Near-fault spectrum with  $R=1$  km
