# Performance of a post-Byzantine Triple-domed Basilica under Near and Far Fault Seismic Loads:

## Analysis and Intervention

Constantine C. Spyrakos, Charilaos A. Maniatakis, Panagiotis Kiriakopoulos, Alessio Francioso, Ioannis M. Taflampas  
*National Technical University of Athens, Greece*

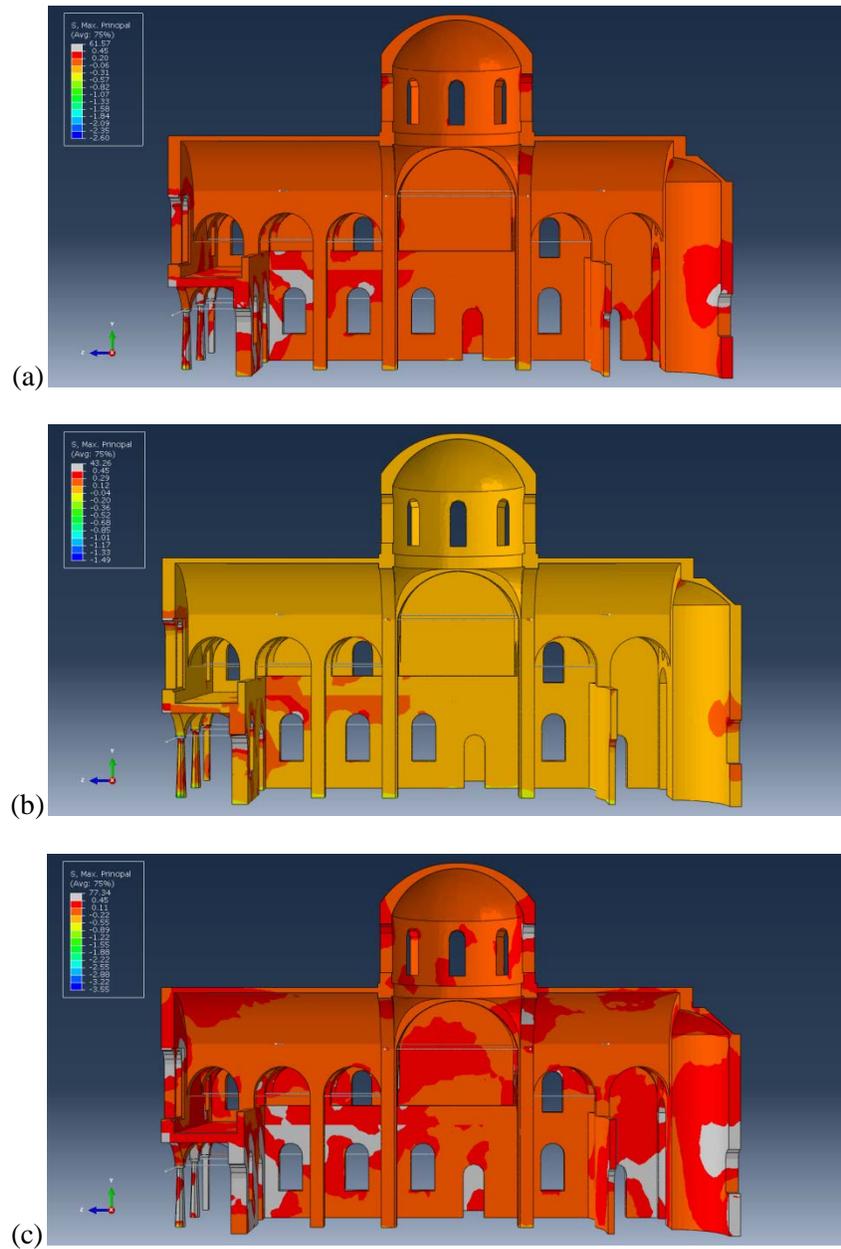
Figure 25. North internal façade - Distribution of maximum stresses in the strengthened model for the  $G+0.5Q+Ex+0.3Ey$  combination: (a) Eurocode 8 spectrum; (b) 1959-Greek Seismic Code spectrum; (c) Near-fault spectrum with  $R=1$  km

Modal response spectrum analysis is performed for the four seismic scenarios and the results regarding the structure after interventions are depicted in Figures 22, 23, 24 and 25 for the west, south, east and north façade, respectively. For reasons of comparison, Figures 22-25 follow the same arrangement with Figures 15-18 that correspond to the stress distribution in initial condition prior the interventions. After the application of the rehabilitation scheme the exceedance of tensile strength is limited mainly at masonry elements of decrease structural value, as regards the stress distribution for the EC-8 and the GC-59 spectra (Figures 22-25 (a) and (b)). The greater part of the façades surface is depicted with a pale color in the contour display that suggests non-exceedance of the tensile strength. Maximum displacement at the top of the dome is 13.7 mm, a value acceptable for life-safety performance.
